OCTOBER 2021

# EFFECT OF ENVIRONMENTAL FACTORS ON ADAS SENSOR PERFORMANCE

NewsRoom.AAA.com

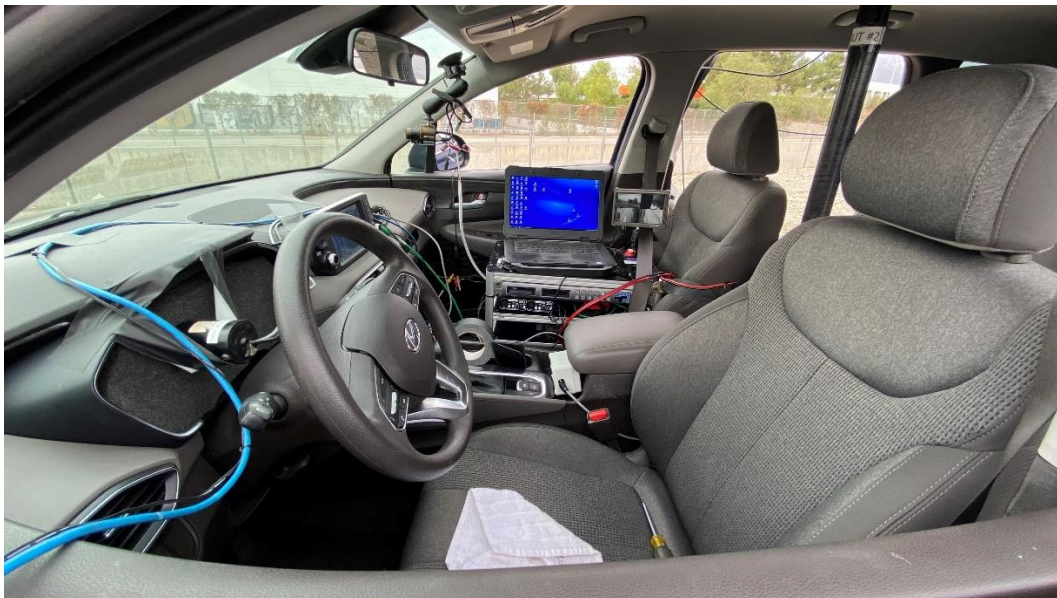
Figure 4: Data acquisition system and sensors installed in test vehicle Image Source: AAA

Sensor inputs and data from the OxTS instrumentation were logged and time synced. Vehicle kinematics and range data were captured at a rate of 100 Hz; the visual and audible alert data were logged at a rate of 100 Hz and 10 000 Hz, respectively. The data acquisition system was equipped with anti-aliasing filters to attenuate frequencies above the Nyquist frequency.

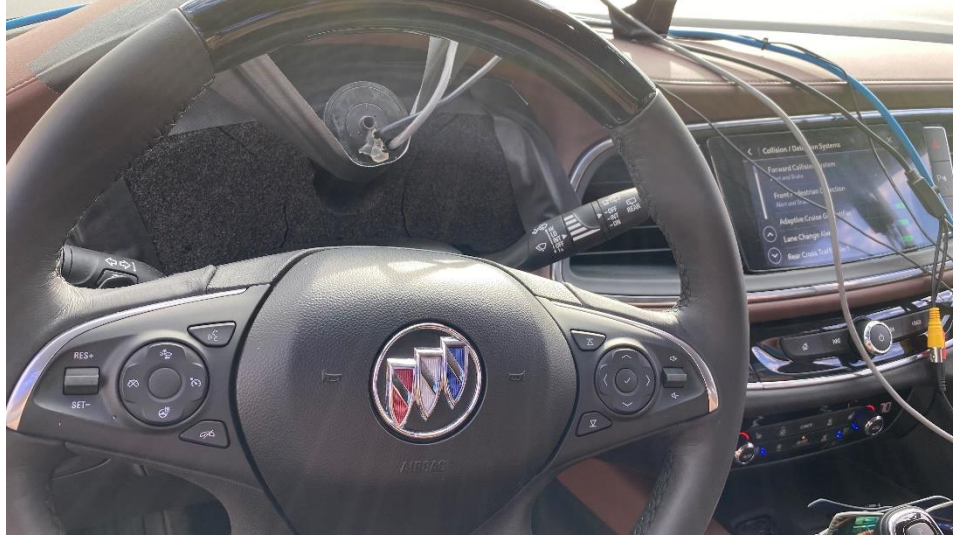
**Figure 5: Light sensor for characterization of visual system alerts** Image Source: AAA

Each test vehicle was equipped with a light sensor and a microphone to capture visual and audible warnings provided by the lane keeping assistance or automatic emergency braking system.

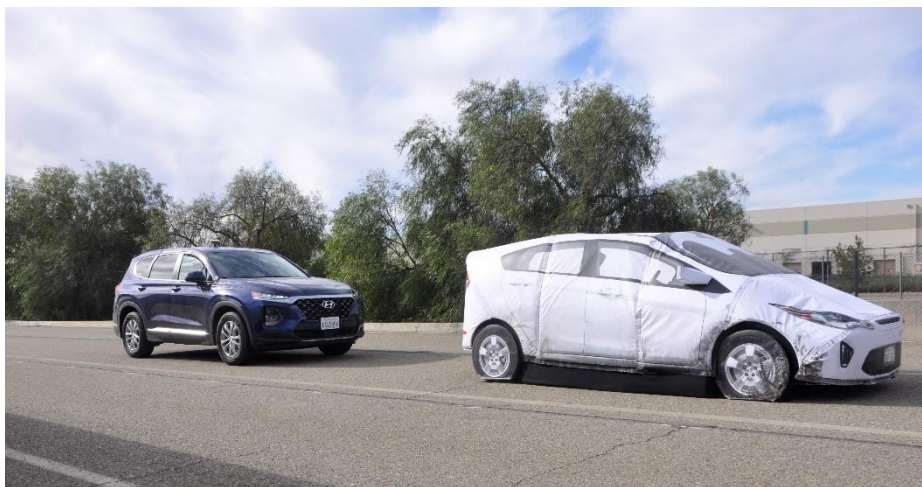
**Figure 6: DRI Low Profile Robotic Vehicle (Static Base)** Image Source: AAA

The Soft Car 360® is calibrated to be representative of a small passenger vehicle relevant to automotive sensors including radar and cameras. The hatchback model was utilized for testing; its length, width, and height are 158 in, 67 in, and 56 in, respectively.

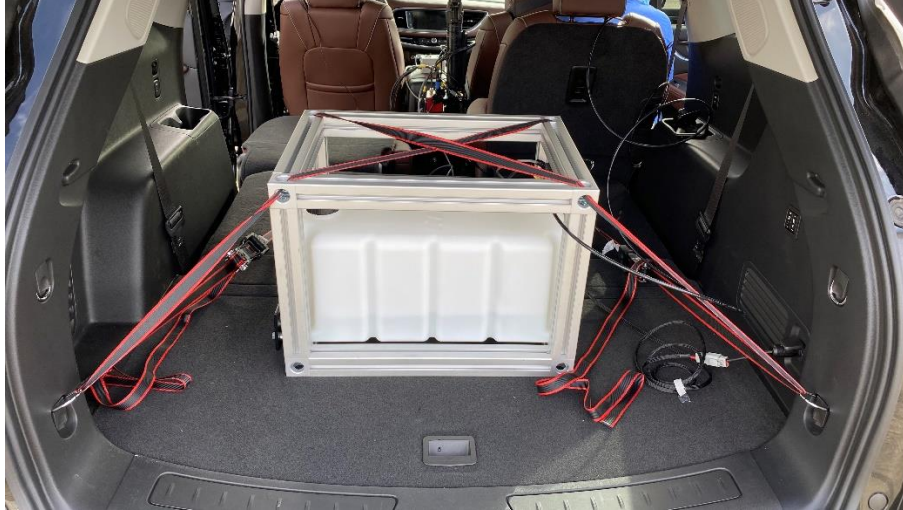
**Figure 7: Simulated Rain System** Image Source: AAA

To simulate the effect of rainfall on advanced driver assistance cameras mounted behind the windshield, a custom fabricated system was mounted in the vehicle.

This system was designed to be a stand-alone component that could be secured in the cargo area and not move under decelerations exhibited in a typical automatic emergency braking event. To minimize variations in water volume and spray pattern, a precision injector nozzle and water/methanol high-pressure injection pump was utilized to ensure a consistent flowrate of 1L/min. A 5-gallon reservoir was integrated to allow for continuous execution of all test runs for each vehicle. The nozzle was positioned such that the spray pattern covered the entire windshield.

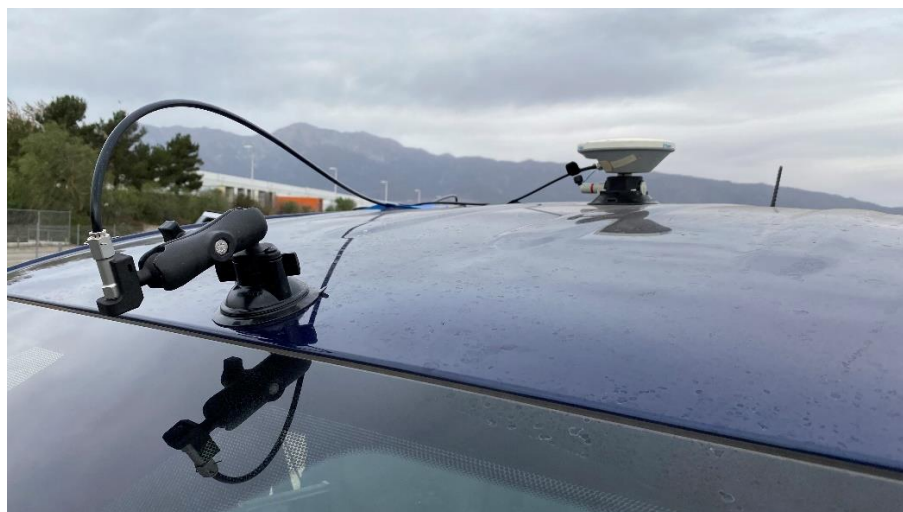
**Figure 8: Rain system injector nozzle and mount.** Image source: AAA

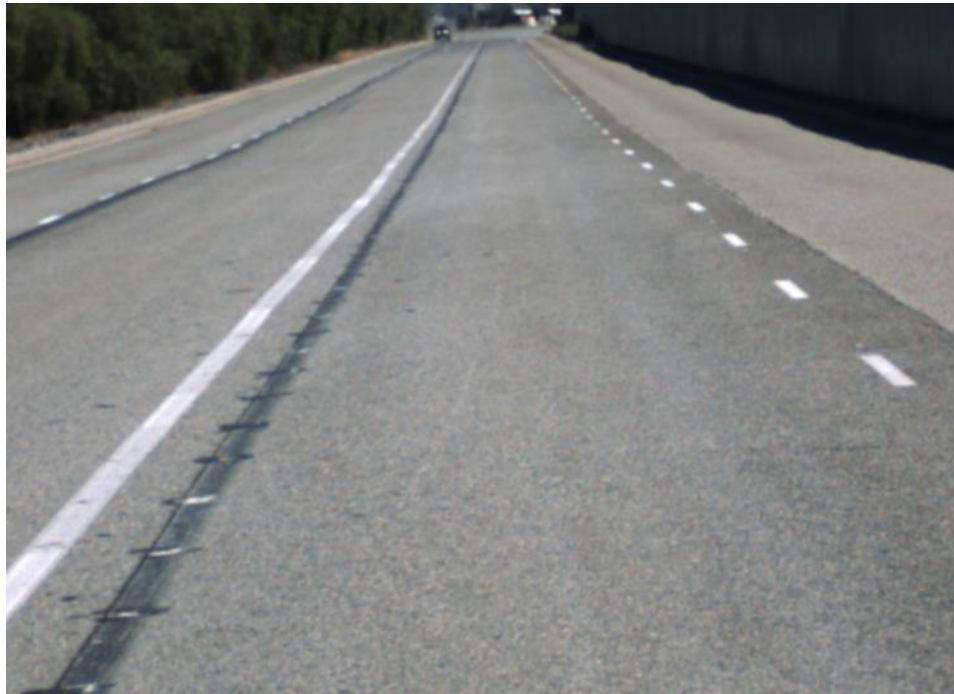
Figure 9: Test lane for closed-course evaluation Image Source: AAA

All track testing was conducted on closed surface streets on the grounds of the Auto Club Speedway in Fontana, CA. All testing was conducted on a dry asphalt surface free of visible moisture. The test lane was characterized by a width of 12 feet and a testing length of approximately 1900 feet. The lane marker on the right consisted of a solid white line while the lane marker on the left consisted of a broken white line divided into portions of equal length. The lane was generally straight with the exception of a slight right curve at the end of the testing portion. The pavement was in good condition with some minor ruts; this is representative of most well-maintained public roadways.

Before testing, the test lane was mapped using OxTS Lane Survey and Map Creation software.

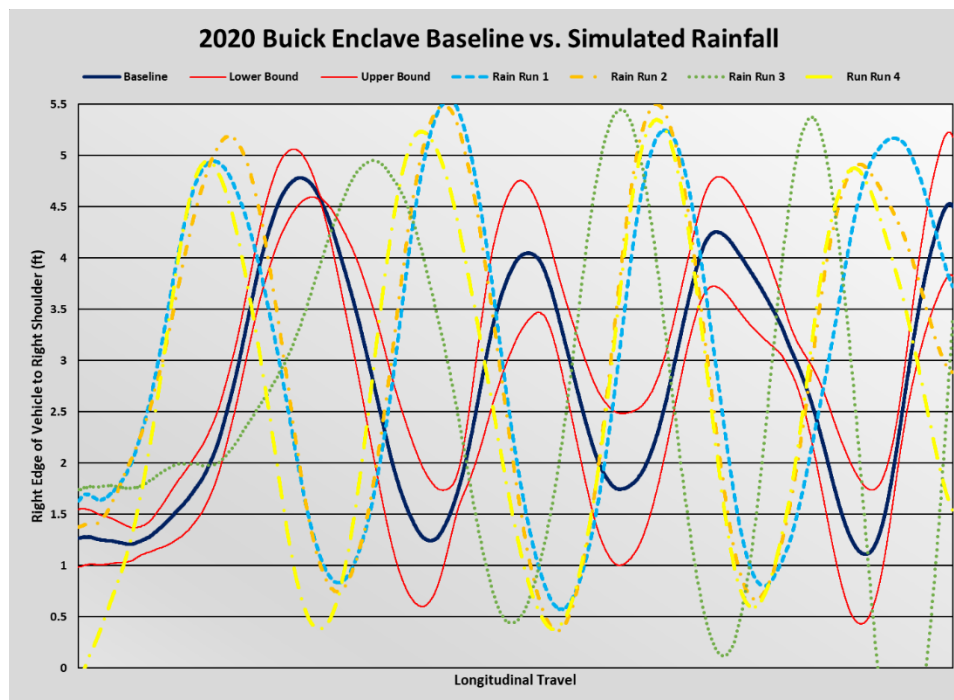
**Figure 10: 2020 Buick Enclave averaged baseline lane placement and individual runs with simulated rainfall**

Figure 10 illustrates a graphical representation of the test vehicle lateral placement for the characteristic baseline run in comparison to the four individual test runs conducted with simulated rainfall. Quasiperiodicity is exhibited for baseline and simulated rainfall conditions analogous in appearance to an irregular sinusoidal wave. Specifically, this indicates significant “ping-ponging” throughout the entirety of the testing lane for both conditions. It is important to note that this is not characteristic of a system flaw in isolation.

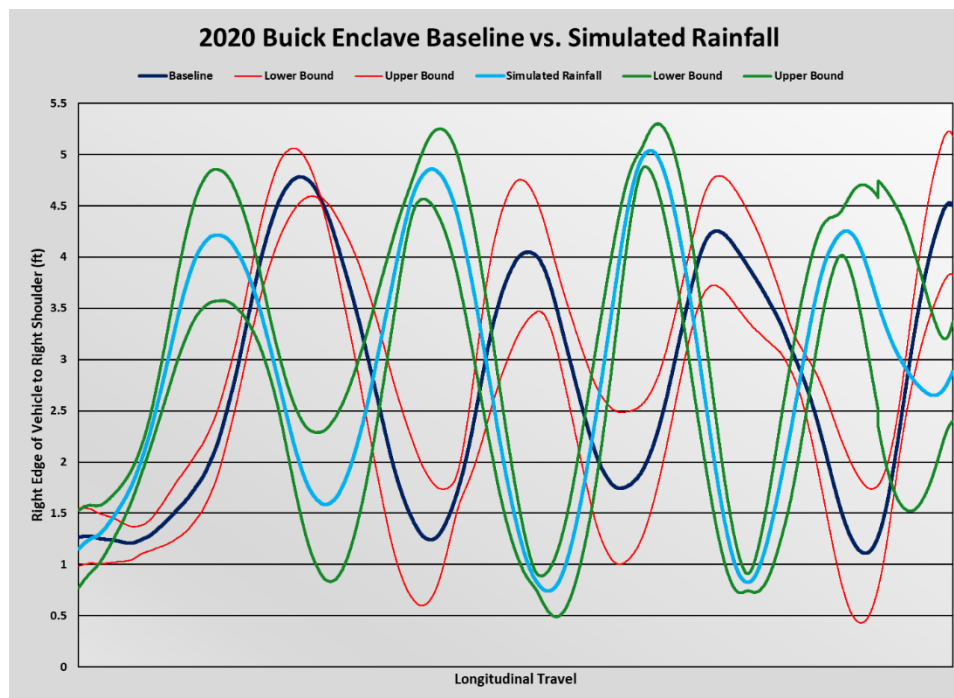
**Figure 12: 2020 Buick Enclave averaged baseline and simulated rainfall lane placement**

Two differences relate to the increased lateral deviation (peak-to-peak amplitude) and increased occurrence of “ping-ponging” (peak-to-peak frequency) of test runs conducted with simulated rainfall relative to baseline conditions. These differences persist when simulated rainfall test runs are averaged as shown in Figure 12. These variations imply that lane keeping assistance system performance is influenced by significant rainfall. Specifically, significant rainfall may result in larger and more frequent lateral deviations within the travel lane if the driver fails to provide steering input.

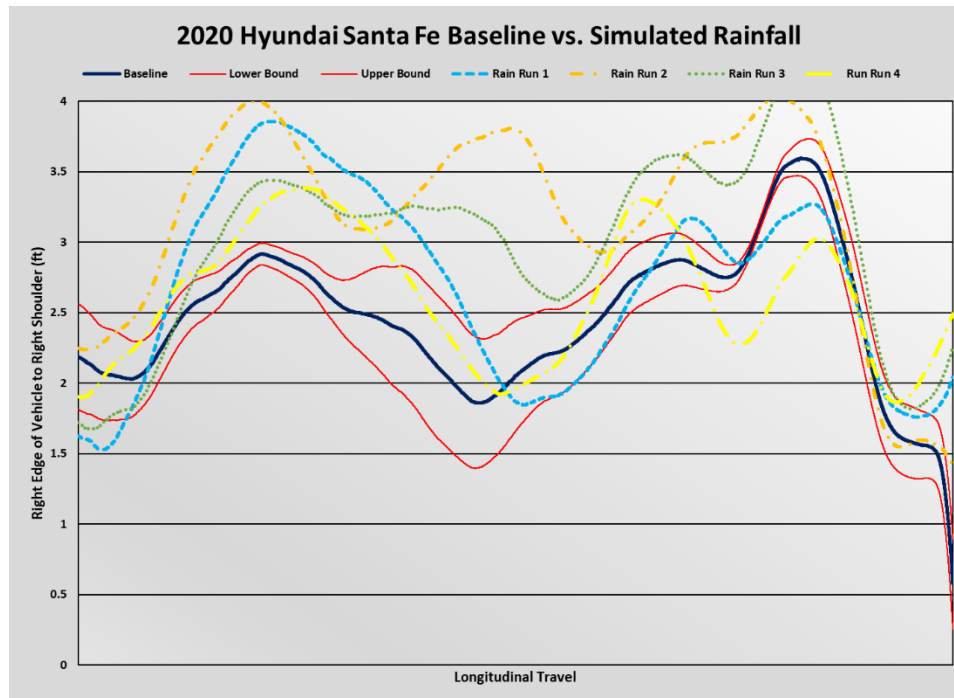
**Figure 13: 2020 Hyundai Santa Fe average baseline lane placement and individual runs with simulated rainfall**  
Image Source: AAA

Figure 13 illustrates a graphical representation of the test vehicle lateral placement for the characteristic baseline run in comparison to the four individual test runs conducted with simulated rainfall. Quasiperiodicity is exhibited for baseline and simulated rainfall conditions not similar in appearance to any common mathematical functions. While the lane placement is generally similar between baseline and simulated rainfall conditions, the lateral lane placement for simulated rainfall conditions is generally biased to the left of the testing lane throughout the test until the end of the run.

As previously noted in Figure 13, test runs conducted with simulated rainfall have a persistent bias to the left of the testing lane throughout the test run until the end. This is illustrated by the average of simulated rainfall test runs in Figure 15. However, lane keeping assistance system performance is generally similar in the second half of the run indicating either a corrective and/or adaptive response to simulated rainfall. In combination, these observations suggest that while system performance may be initially influenced, the system is also capable of corrective and/or adaptive actions in response to significant rainfall.

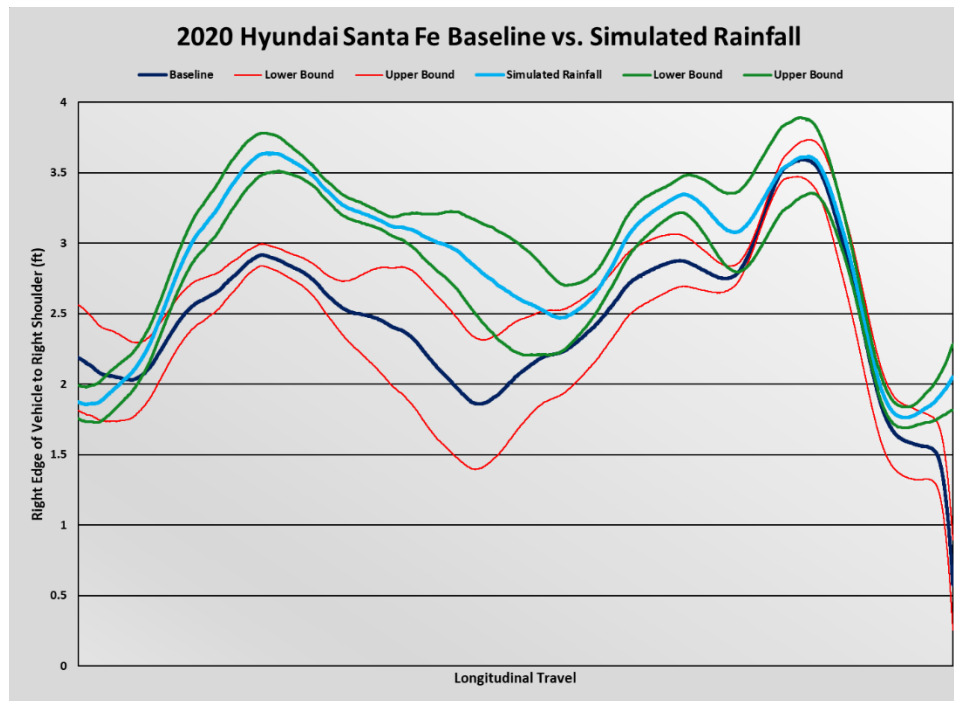
**Figure 15: 2020 Hyundai Santa Fe averaged baseline and simulated rainfall lane placement**  
Image Source: AAA

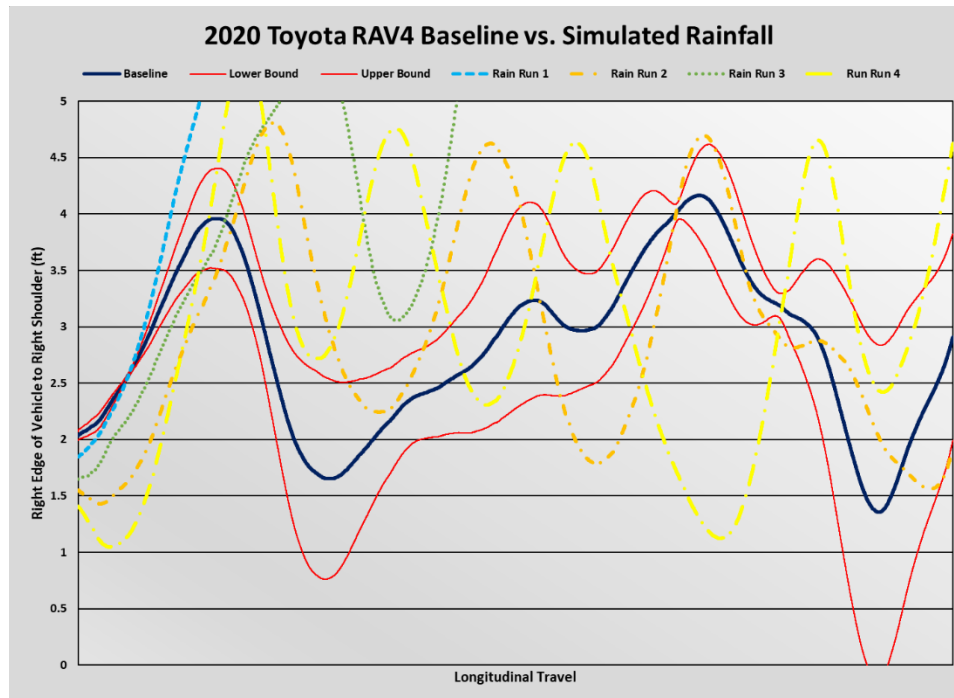
**Figure 16: 2020 Toyota RAV4 average baseline lane placement and individual runs with simulated rainfall** Image Source: AAA

Figure 16 illustrates a graphical representation of the test vehicle lateral placement for the characteristic baseline run in comparison to the four individual test runs conducted with simulated rainfall. It is important to note that the characteristic baseline run is only comprised of three individual baseline test runs because the test vehicle left the roadway for one of the four baseline runs. To ensure parity between baseline and simulated rainfall scenarios, an additional baseline test run was not performed because test runs conducted with simulated rainfall were counted as valid even if the test vehicle left the roadway prior to completion of the test run.

Quasiperiodicity is exhibited for baseline and simulated rainfall conditions; however, the general appearance between the characteristic averaged run and individual test runs with simulated rainfall is significantly different. The characteristic baseline run does not resemble any common mathematic function whereas the second and fourth test runs are analogous in appearance to an irregular sinusoidal wave. The test vehicle left the testing lane during the first and third test runs. Specifically, test runs conducted with simulated rainfall exhibited significantly more “ping-ponging” than the characteristic baseline run. Significant differences between all individual simulated rainfall test runs with respect to the characteristic baseline run imply that the lane keeping assistance system is influenced by significant rainfall.

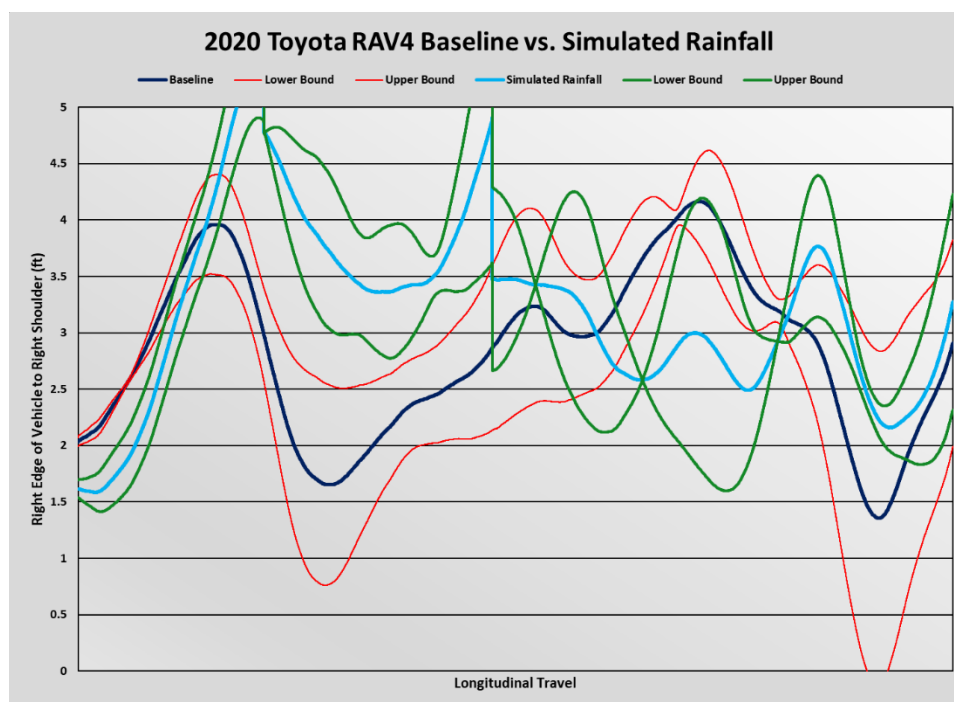
**Figure 18: 2020 Toyota RAV4 averaged baseline and simulated rainfall lane placement** Image Source: AAA

The average baseline and simulated rainfall test runs are illustrated in Figure 18. If the test vehicle leaves the roadway prior to completion of the test run, lateral lane placement from that run is only averaged to the longitudinal point at which the test vehicle leaves the roadway. In other words, lateral lane placement from

The standard error bounds intersect at multiple points due to the out of phase and irregular sinusoidal waves that characterize the lateral lane placement for the second and fourth test runs. Figure 18 illustrates that system behavior is significantly different for baseline and simulated rainfall conditions. Specifically, significant rainfall may result in the test vehicle leaving the roadway and/or “ping-ponging” within the travel lane if the driver fails to provide steering input.

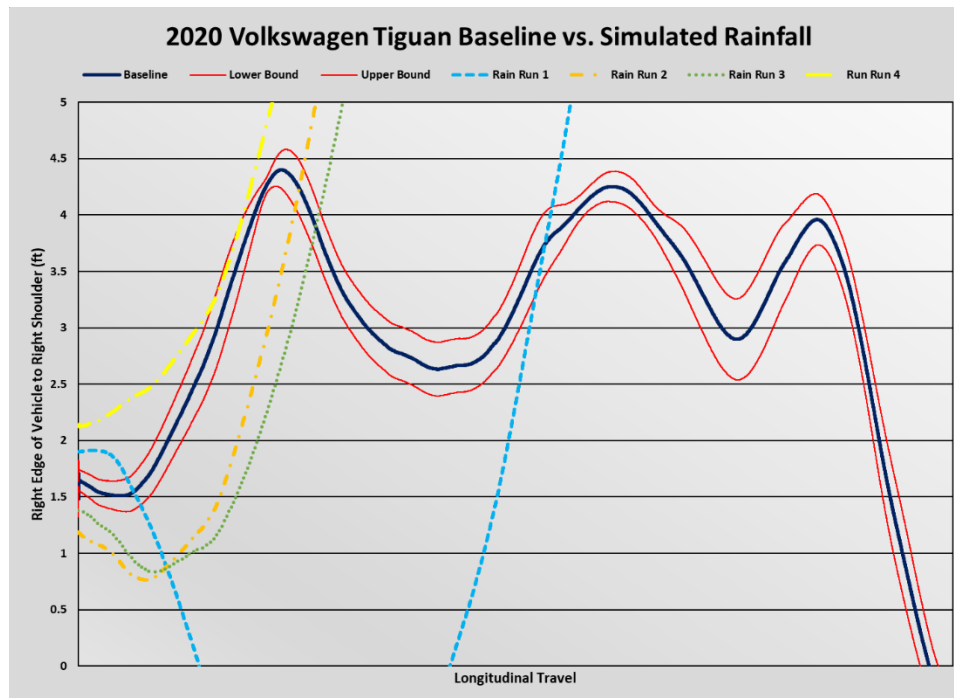
**Figure 19: 2020 Volkswagen Tiguan average baseline lane placement and individual runs with simulated rainfall**

The finding that the test vehicle left the roadway for all individual simulated rainfall test runs prior to test completion imply that the lane keeping assistance system is influenced by significant rainfall. Specifically, significant rainfall may result in the test vehicle leaving the roadway if the driver fails to provide steering input.

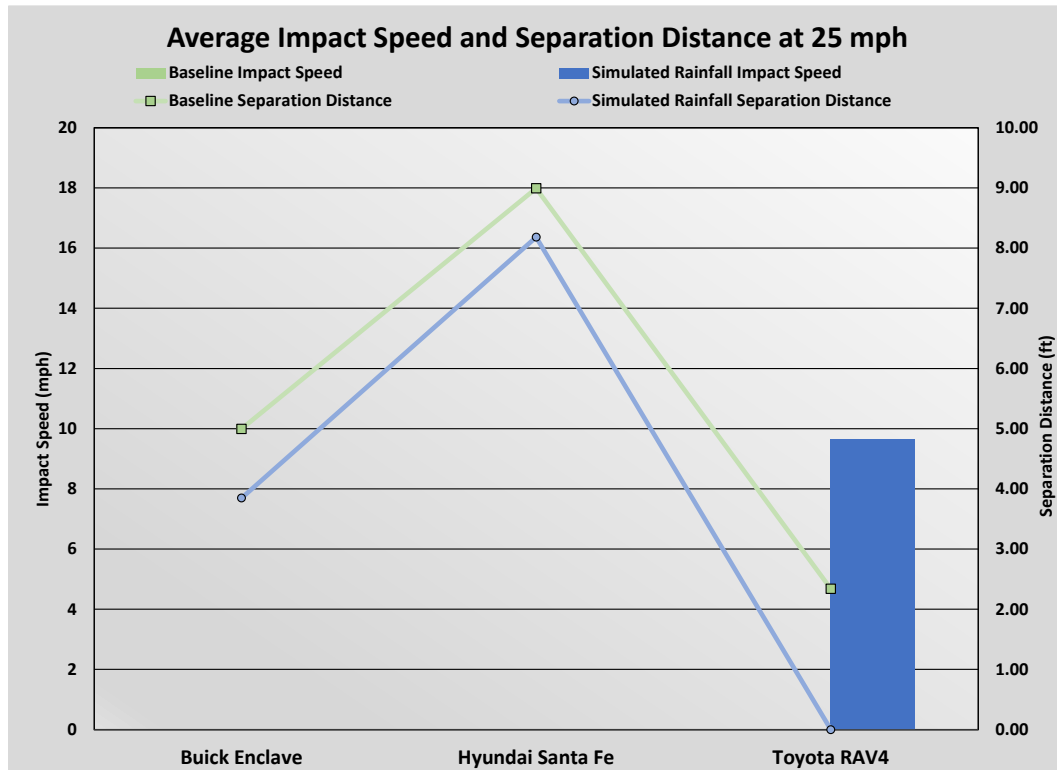
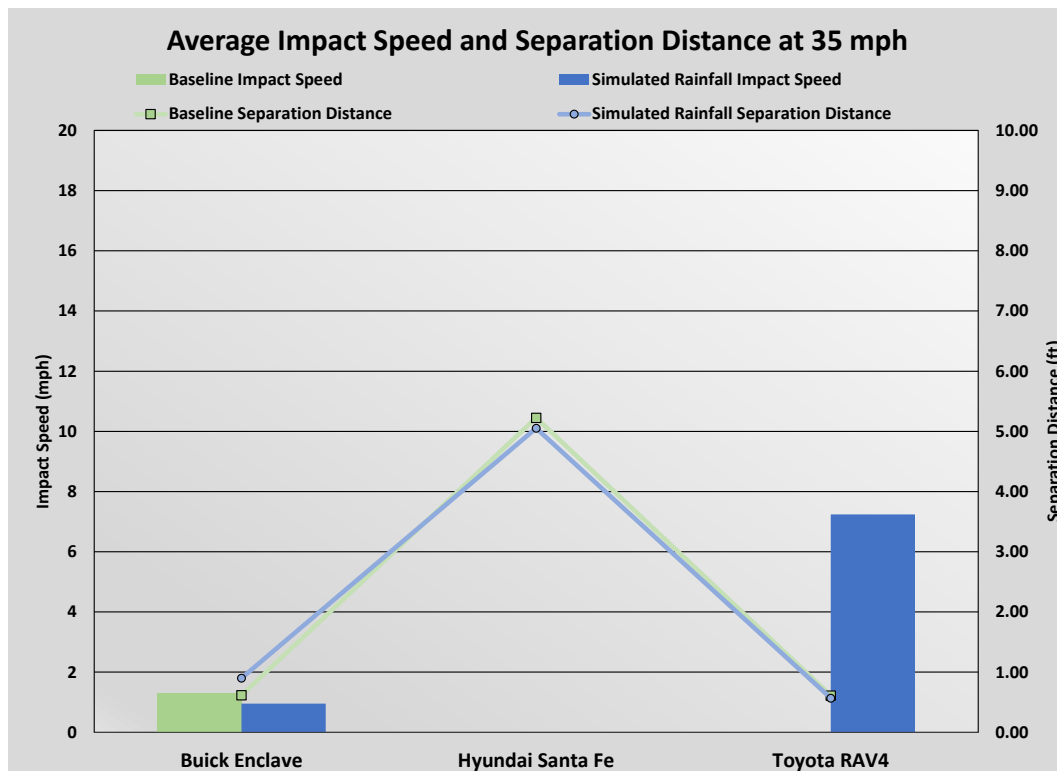
Figure 26: Average impact speed and final separation distance for each test vehicle at 25 mph  
Image Source: AAA

Figure 27: Average impact speed and final separation distance for each test vehicle at 35 mph

Figures 26 and 27 illustrate the average impact speed and associated separation distance for baseline and simulated rainfall conditions for each test vehicle at 25 mph and 35 mph, respectively.

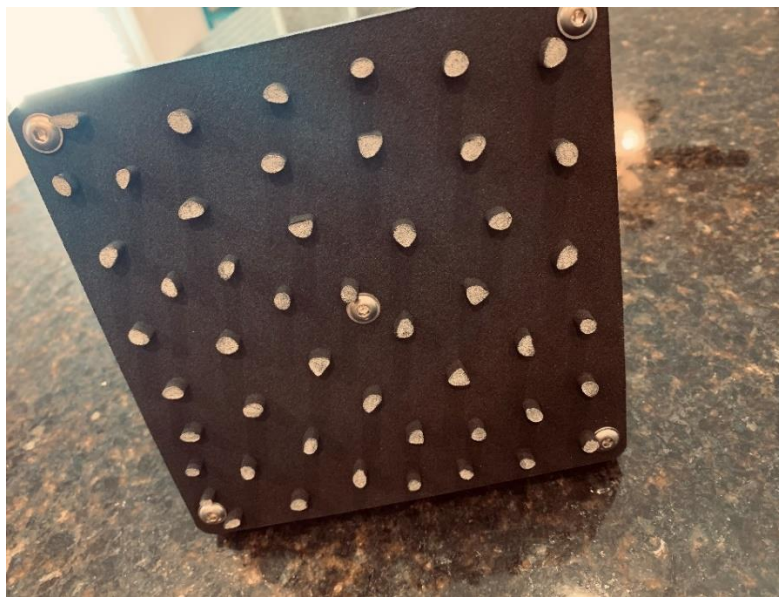
Figure 30: Spot pattern of stamp applicator Image Source: AAA

In order to evaluate system performance with sufficient repeatability, closed-course testing was utilized to ensure a controlled environment with consistent testing conditions. To simulate occluded cameras caused by a dirty windshield, a concentrated solution of dirt and bug particles was applied to the glass around system cameras in a consistent pattern. Specifically, a custom fabricated stamp applicator was utilized to apply the solution to the glass in a repeatable manner. The stamp applicator consisted of a square plate six inches in length and width with a protruding random spot pattern. The applicator was dipped in solution and applied to the windshield to produce a consistent pattern of dirt and bug particles in front of and around system cameras located behind the windshield.

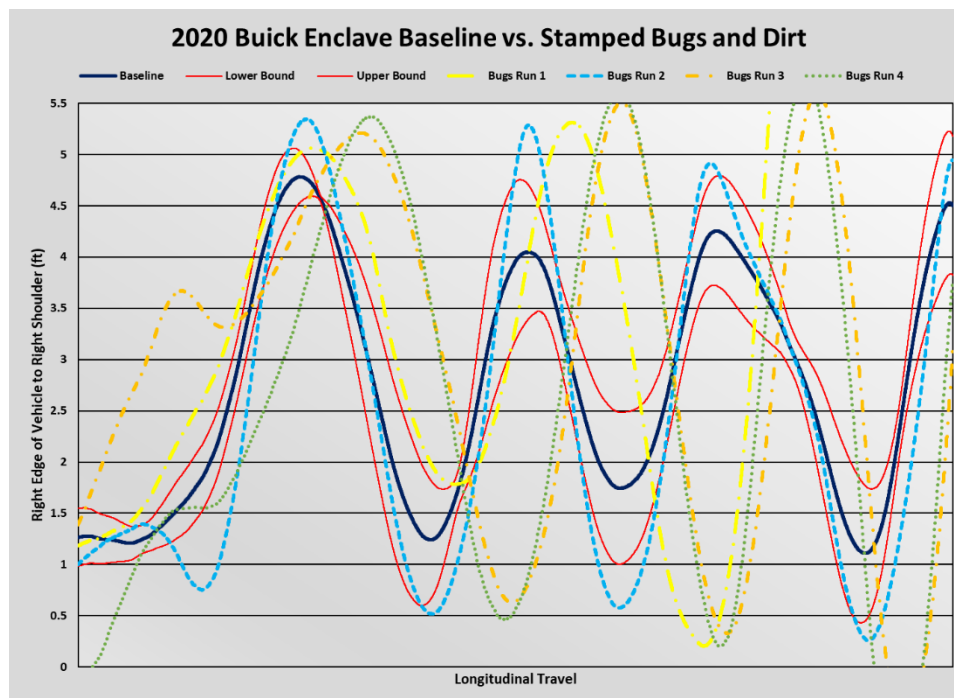
**Figure 31: 2020 Buick Enclave average baseline lane placement and individual runs with occluded cameras** Image Source: AAA

Figure 31 illustrates a graphical representation of the test vehicle lateral placement for the characteristic baseline run in comparison to the four individual test runs conducted with occluded system cameras. Quasiperiodicity is exhibited for baseline and occluded camera conditions analogous in appearance to an irregular sinusoidal wave. Specifically, this indicates significant “ping-ponging” throughout the entirety of the testing lane for both conditions. It is important to note that this is not characteristic of a system flaw in isolation.

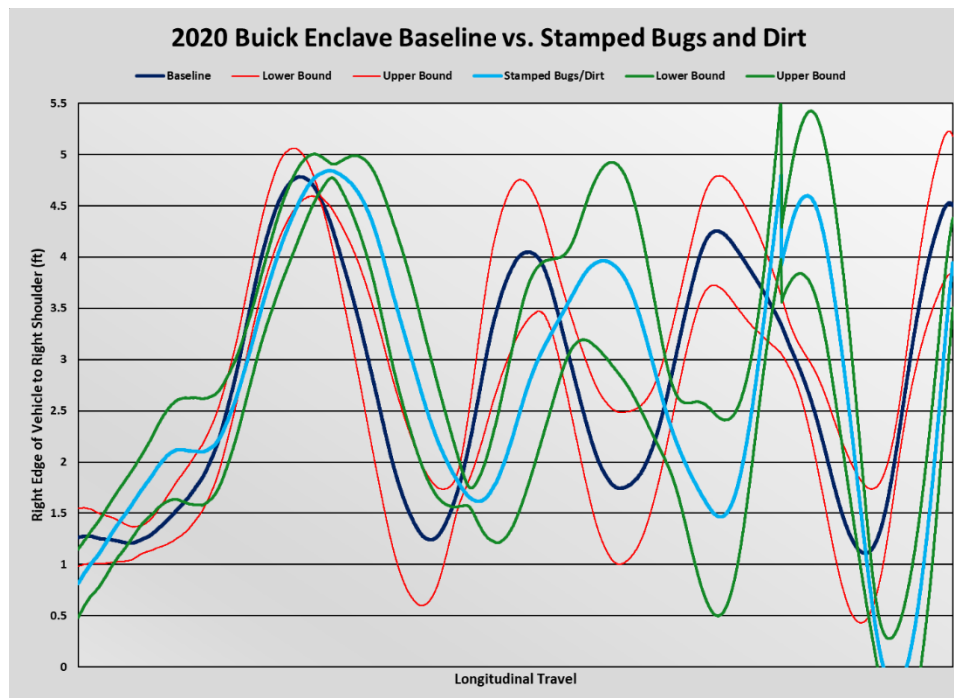
**Figure 33: 2020 Buick Enclave averaged baseline and occluded camera placement**

Based on a comparison of averaged runs, the lane keeping assistance system performance is generally similar in terms of “ping-ponging” lateral deviation and frequency with the exception of one test run leaving the roadway prior to test completion. This implies that system performance is minimally influenced by system cameras occluded with bug and dirt particles.

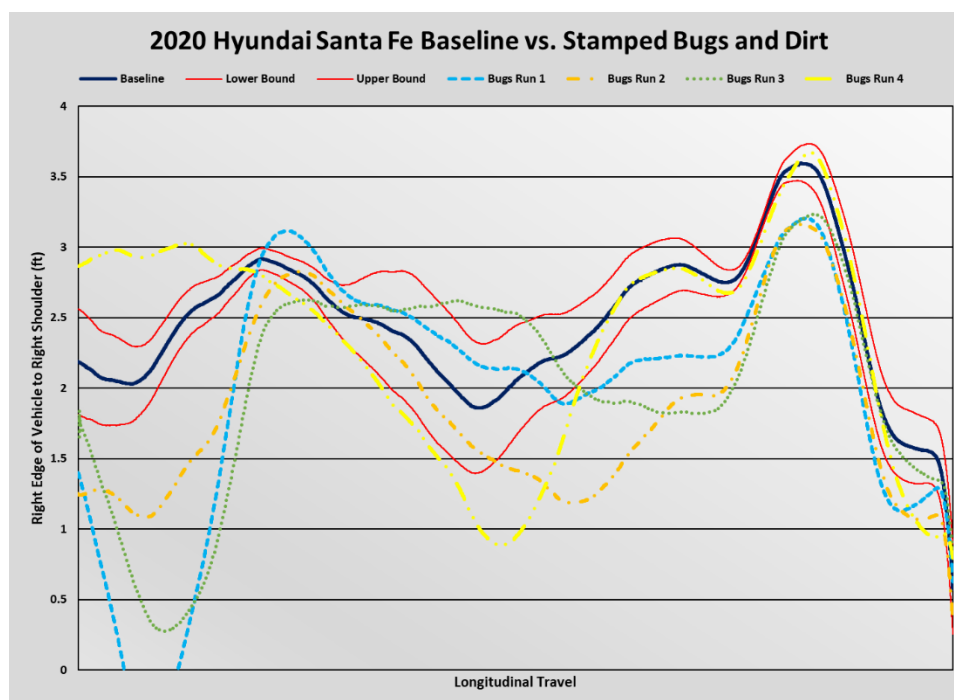
**Figure 34: 2020 Hyundai Santa Fe average baseline lane placement and individual runs with occluded cameras** Image Source: AAA

Figure 34 illustrates a graphical representation of the test vehicle lateral placement for the characteristic baseline run in comparison to the four individual test runs conducted with occluded cameras. Quasiperiodicity is exhibited for baseline and occluded camera conditions not similar in appearance to any common mathematical functions. While the lane placement is generally similar between baseline and occluded camera conditions, the lateral lane placement is more towards the right of the testing lane in the first half of the run.

As previously noted in Figure 34, test runs conducted with occluded cameras have a bias to the right of the testing lane in the beginning of the run. This is illustrated by the average of occluded camera test runs in Figure 36. However, the lane keeping assistance system performance is similar for the remainder of the test run indicating either a corrective and/or adaptive response to occluded cameras. In combination, these observations suggest that while system performance may be initially influenced, the system may also be capable of corrective and/or adaptive actions in response to occluded cameras.

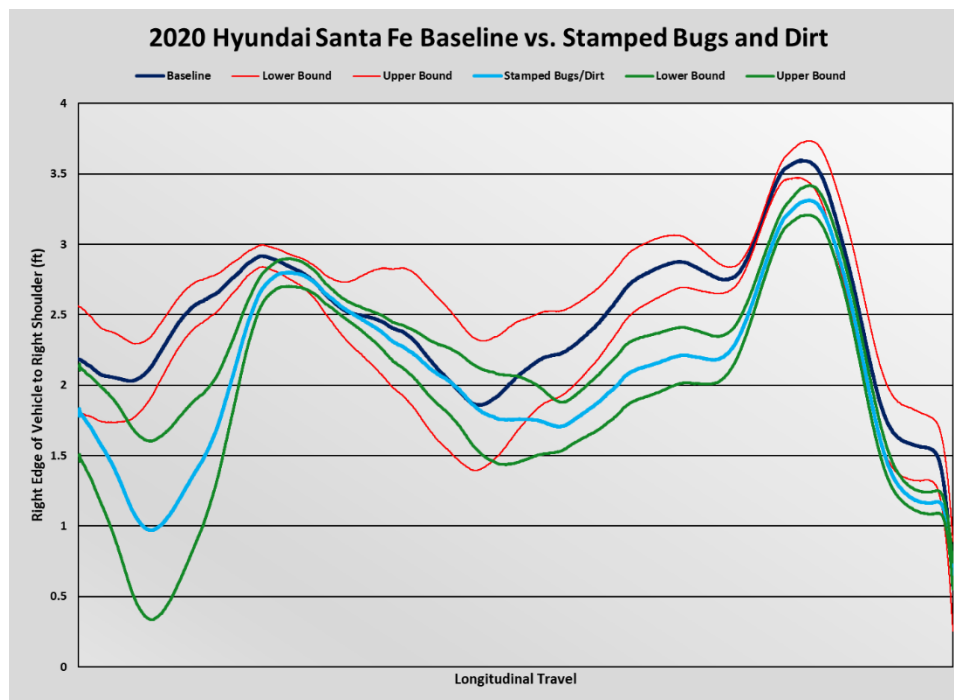
**Figure 36: 2020 Hyundai Santa Fe averaged baseline and occluded camera placement**

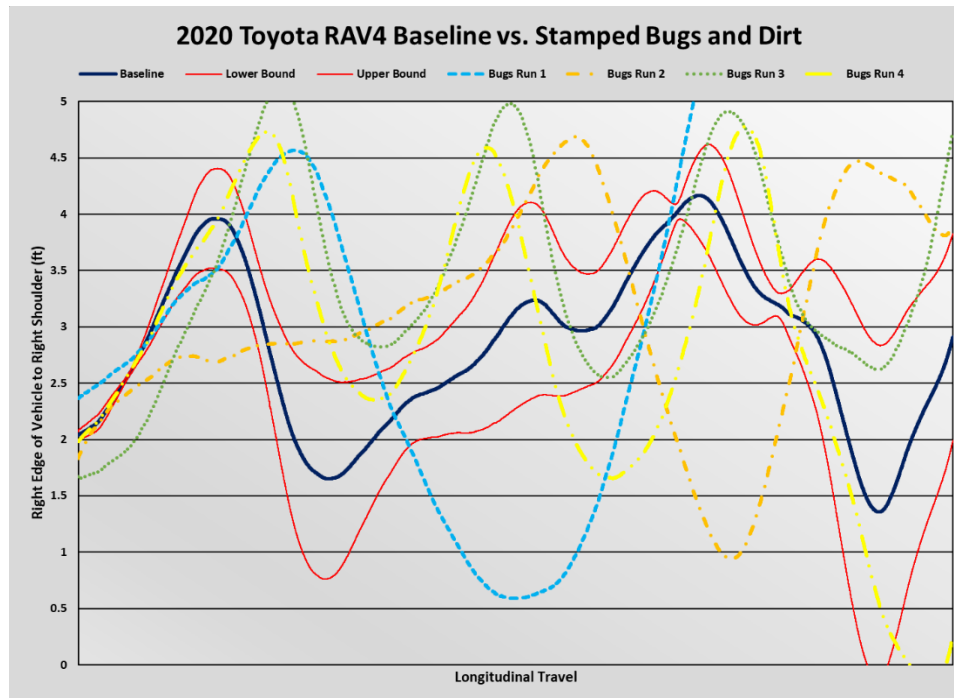
**Figure 37: 2020 Toyota RAV4 average baseline lane placement and individual runs with occluded cameras** Image Source: AAA

Figure 37 illustrates a graphical representation of the test vehicle lateral placement for the characteristic baseline run in comparison to the four individual test runs conducted with occluded cameras. As previously described in [Section VI-C1c](#), the characteristic baseline run is comprised of three individual baseline test runs because as in the previous test, the test vehicle left the roadway for one of the four baseline runs.

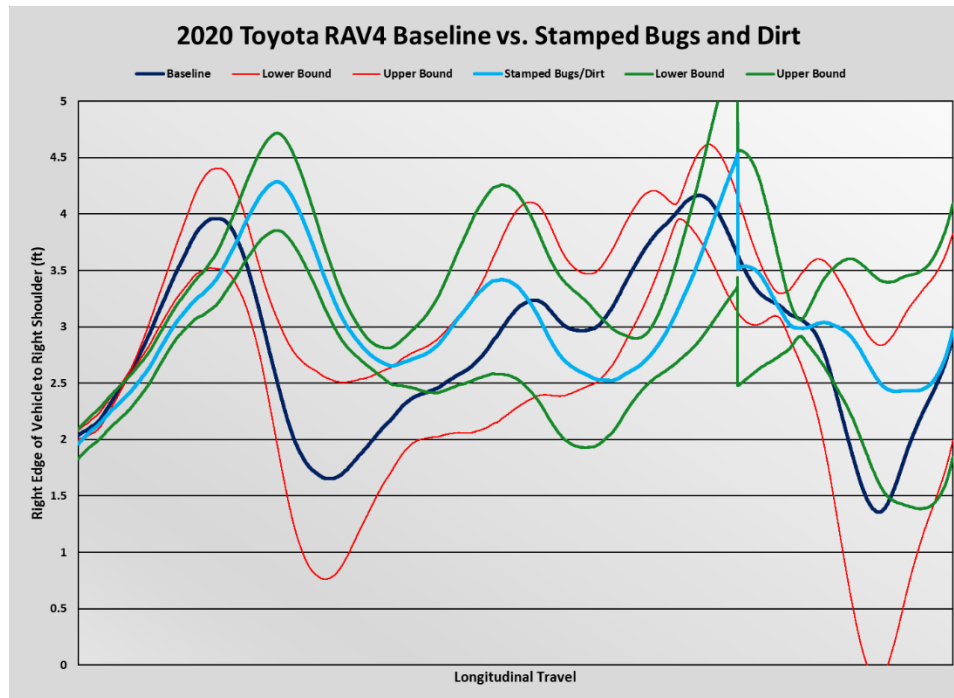
**Figure 39: 2020 Toyota RAV4 averaged baseline and occluded cameras placement**

While individual test runs conducted with occluded cameras do not generally resemble the representative baseline run, the inconsistency of individual baseline runs imply that inconsistency in lateral lane placement is not a function of the simulated bugs and dirt mixture. Additionally, the absolute deviation in lateral lane placement for both conditions is of similar magnitude.

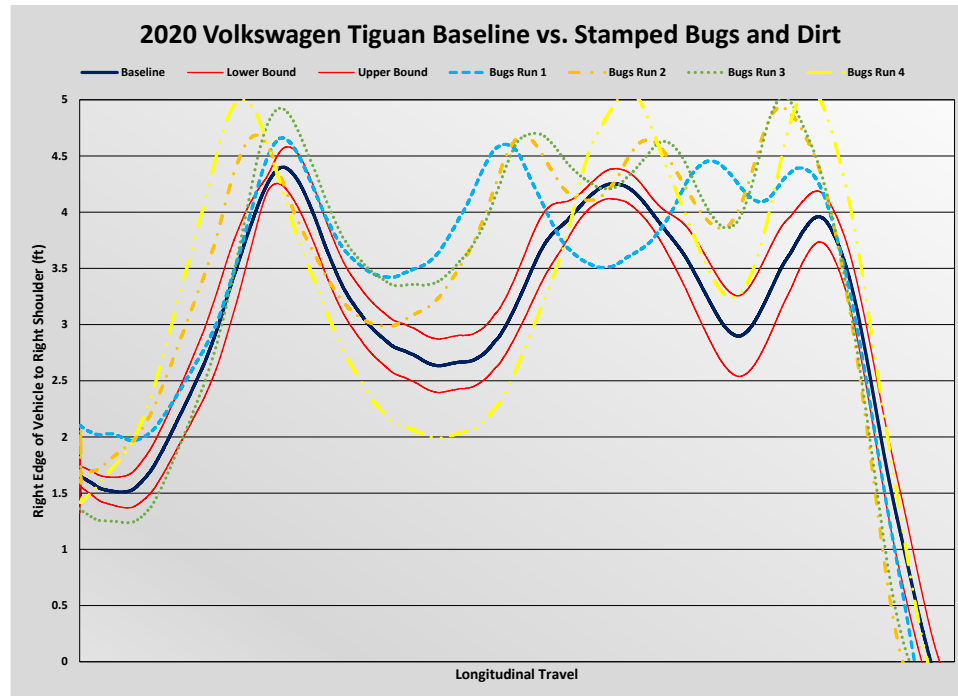
**Figure 40: 2020 Volkswagen Tiguan average baseline lane placement and individual runs with occluded cameras**  
Image Source: AAA

Figure 40 illustrates a graphical representation of the test vehicle lateral placement for the characteristic baseline run in comparison to the four individual test runs conducted with occluded cameras. Quasiperiodicity is exhibited for baseline and occluded camera conditions not similar in appearance to any common mathematical functions. While the lane placement is generally similar between baseline and occluded camera conditions, the lateral lane placement for occluded camera conditions generally exhibit a minor degree of weaving towards the end of the test run.

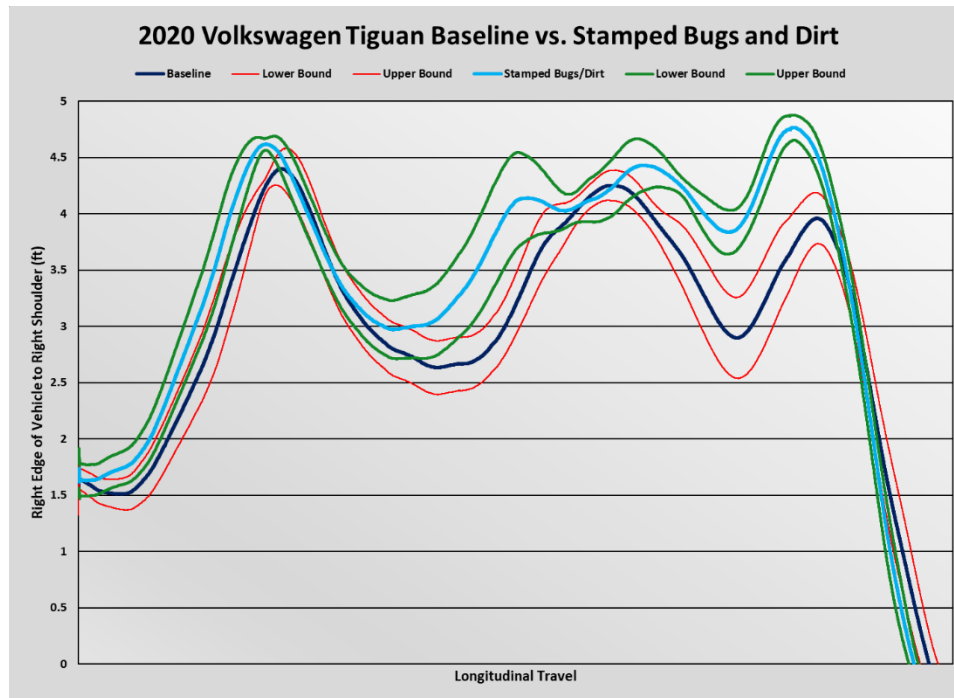
**Figure 42: 2020 Volkswagen Tiguan averaged baseline and occluded cameras placement**  
Image Source: AAA

The average baseline and occluded camera test runs are illustrated in Figure 42. The lane keeping assistance system performance is notably similar throughout the test run indicating that system performance is not significantly influenced by cameras occluded with bug and dirt particles.

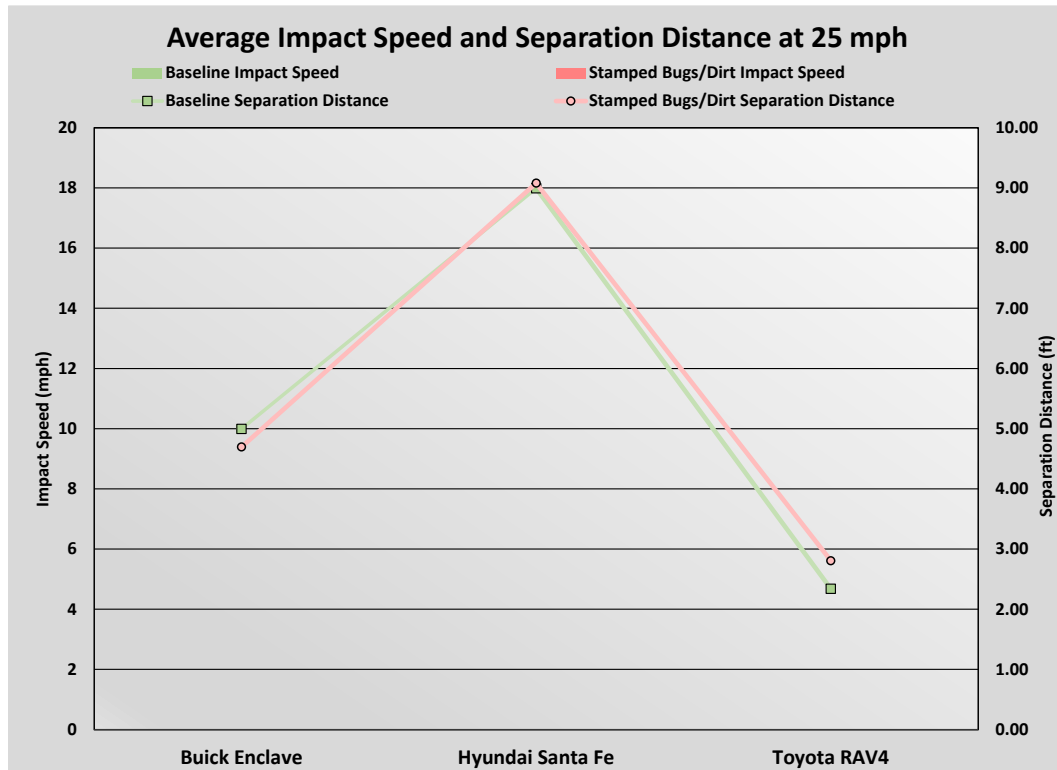
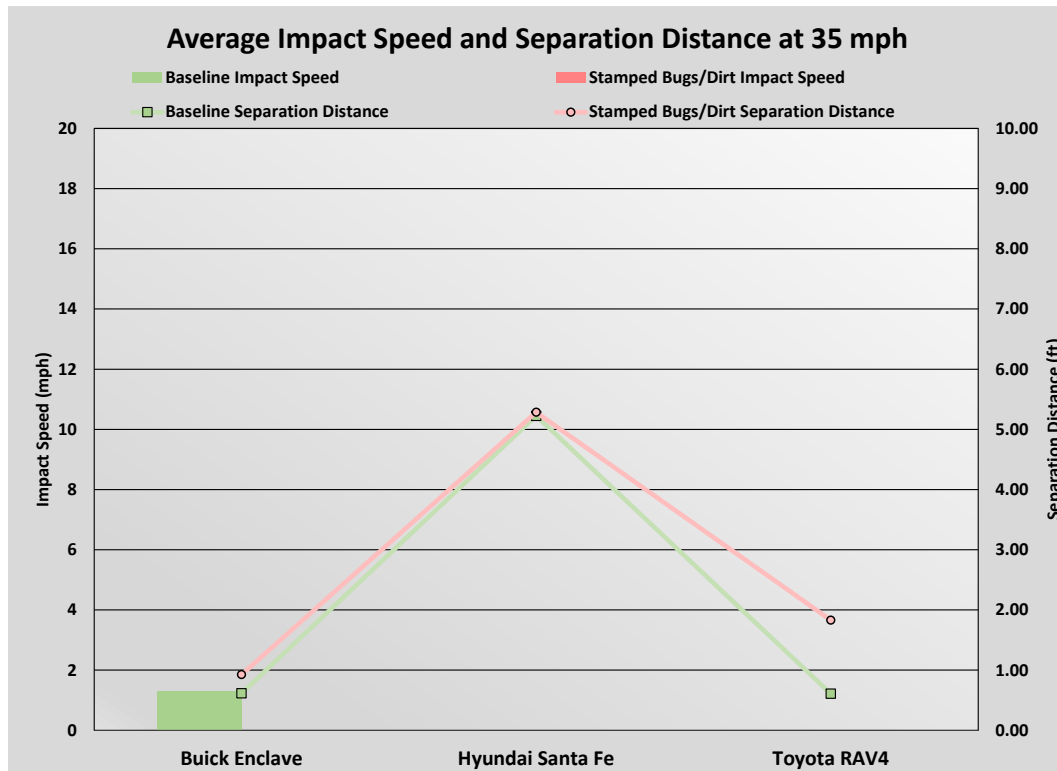
Figure 49: Average impact speed and final separation distance at 25 mph Image Source: AAA

Figure 50: Average impact speed and final separation distance at 35 mph Image Source: AAA

Figures 49 and 50 illustrate the average impact speed and associated separation distance for baseline and occluded camera conditions for each test vehicle at 25 mph and 35 mph, respectively.
