Impact of Speeds on Drivers and Vehicles — Results from Crash Tests

Woon Kim, Ph.D.
Tara Kelley-Baker, Ph.D.
AAA Foundation for Traffic Safety

Raul Arbelaez
Sean O'Malley
Insurance Institute for Highway Safety

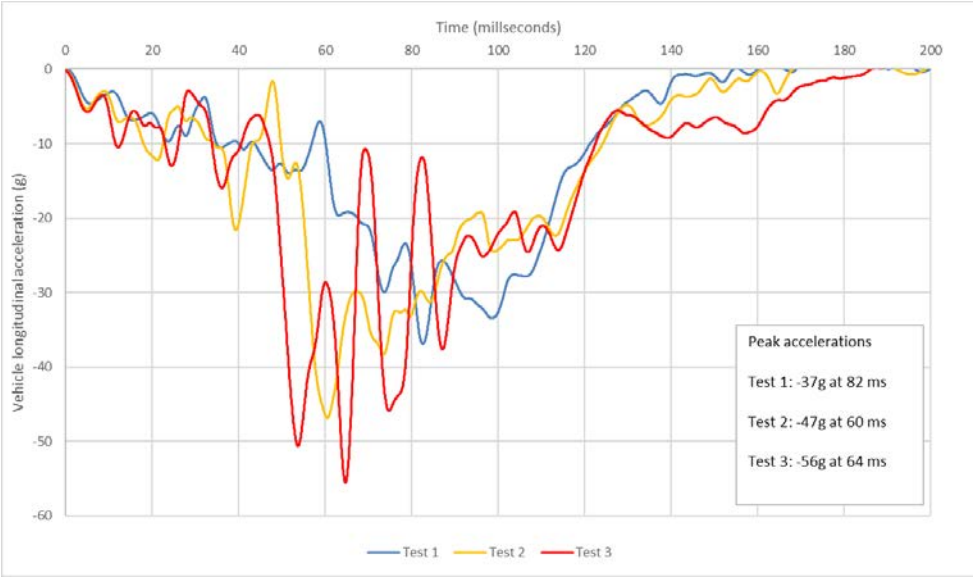
Figure 9. Vehicle longitudinal accelerations

Table 2 summarizes peak vehicle longitudinal accelerations and velocity change (delta-V). For each crash test, the delta-V is greater than the impact velocity due to the additional velocity change resulting from the vehicle rebounding off the fixed barrier (i.e. rearward vehicle motion). Figures 9 and 10 show vehicle acceleration and delta-V during each test. The onset of increased vehicle accelerations in Tests 2 and 3 was caused by the left front wheel being pushed back into the hinge-pillar and lower sill areas. The increased impact velocities in Tests 2 and 3 of 15.6 km/h and 25.6 km/h, respectively, equate to an increase in kinetic energy of 54% and 95% relative to Test 1.

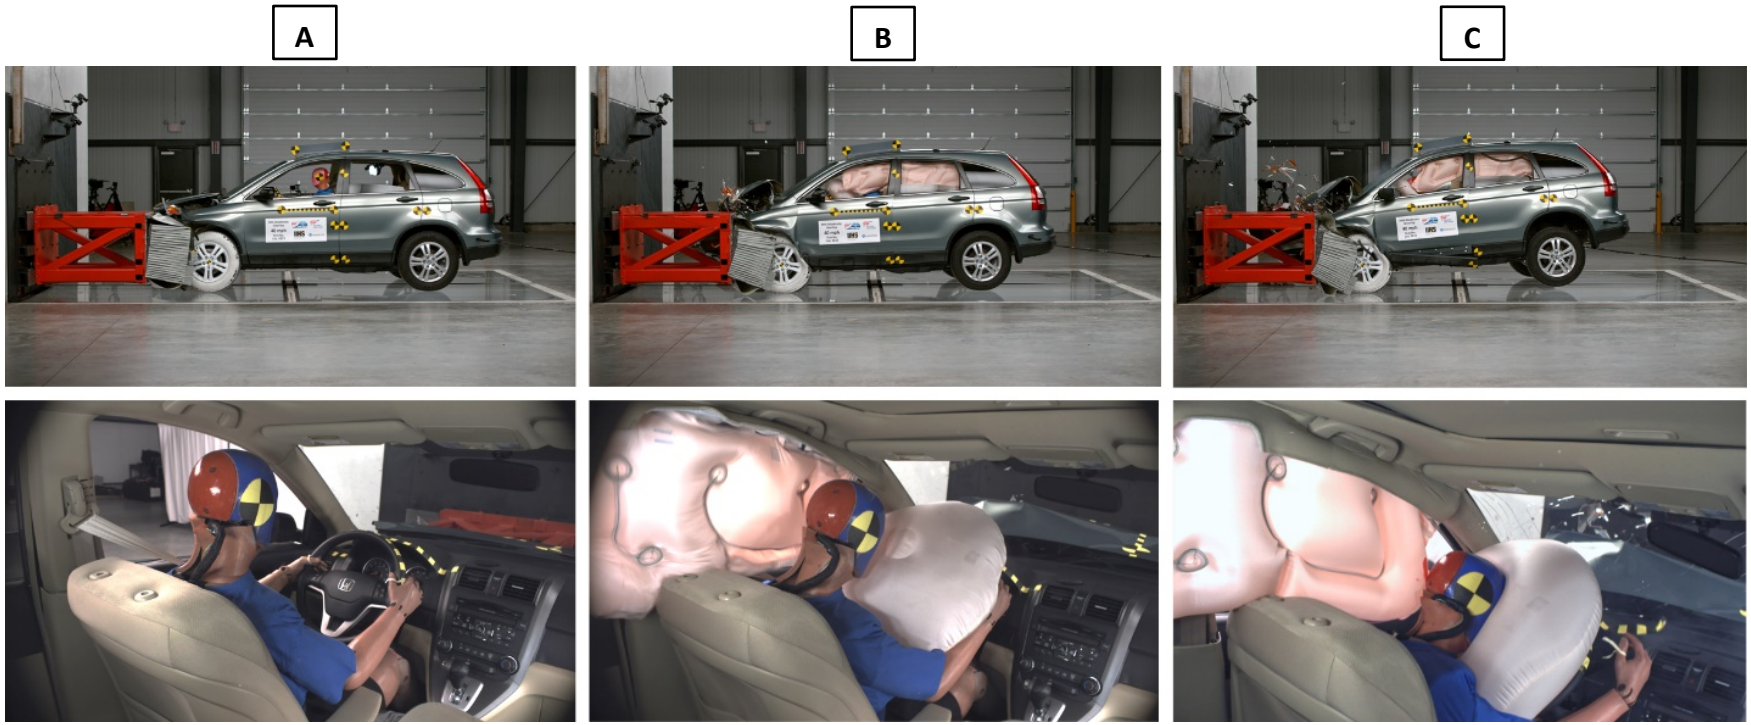
- Test 1 had minimal occupant compartment intrusion. Test 2 resulted in some deformation of the driver side door opening and to the instrument panel and footwell (brake pedal). In contrast, the occupant compartment was significantly compromised in Test 3, narrowing the driver door opening by 4 inches and having 5 to 16 inches greater interior intrusion than in Test 1.

Figure 11. Vehicle and onboard views from Test 1 (64.4 km/h) at 50 ms (column A), 82 ms (column B) when peak vehicle longitudinal acceleration occurs, and 120 ms (column C)

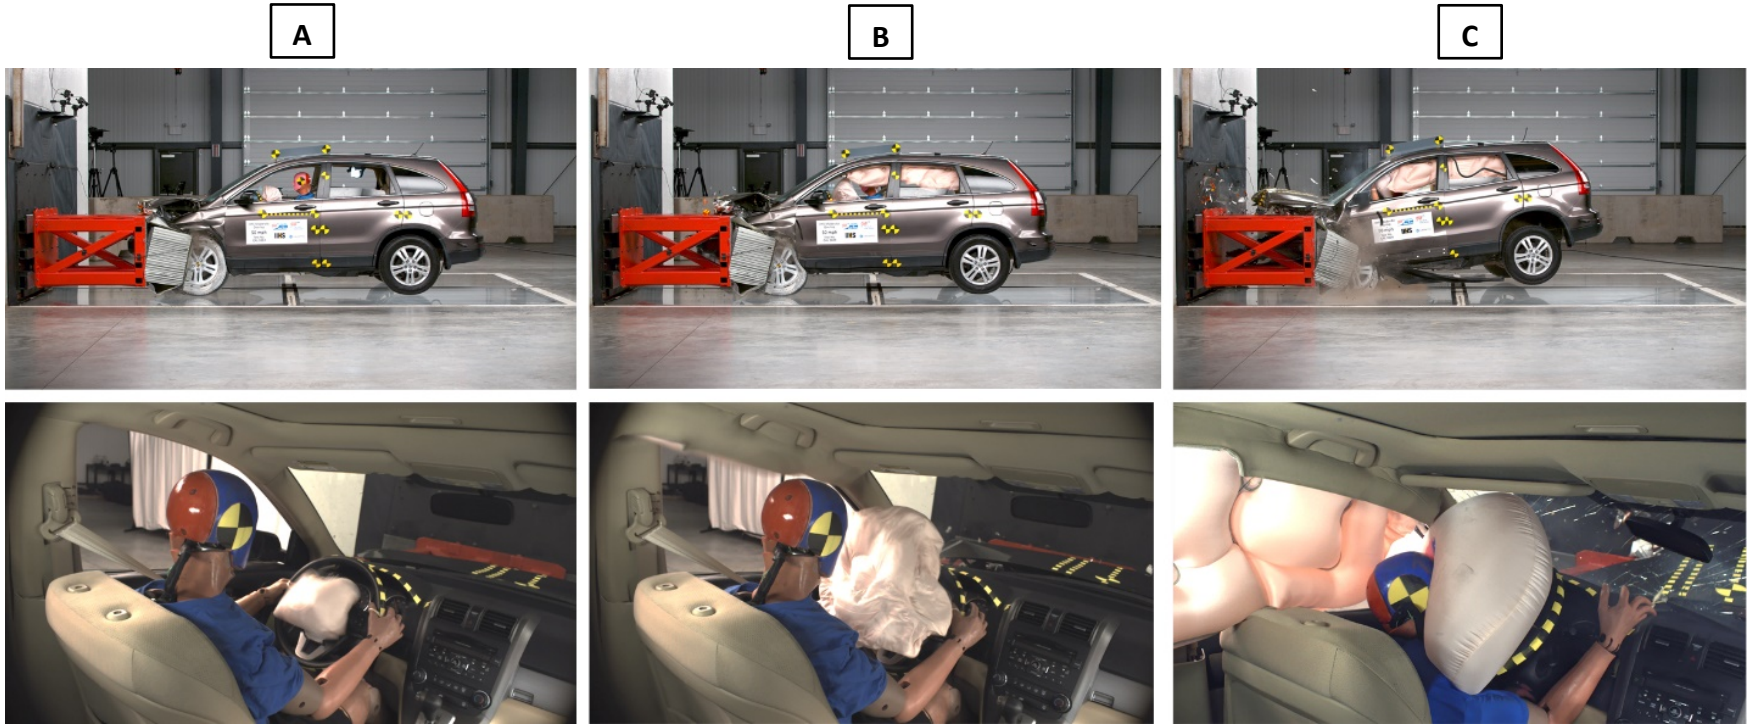
Figure 12. Vehicle and onboard views from Test 2 (80 km/h) at 50 ms (column A), 60 ms (column B) when peak vehicle longitudinal acceleration occurs, and 120 ms (column C)

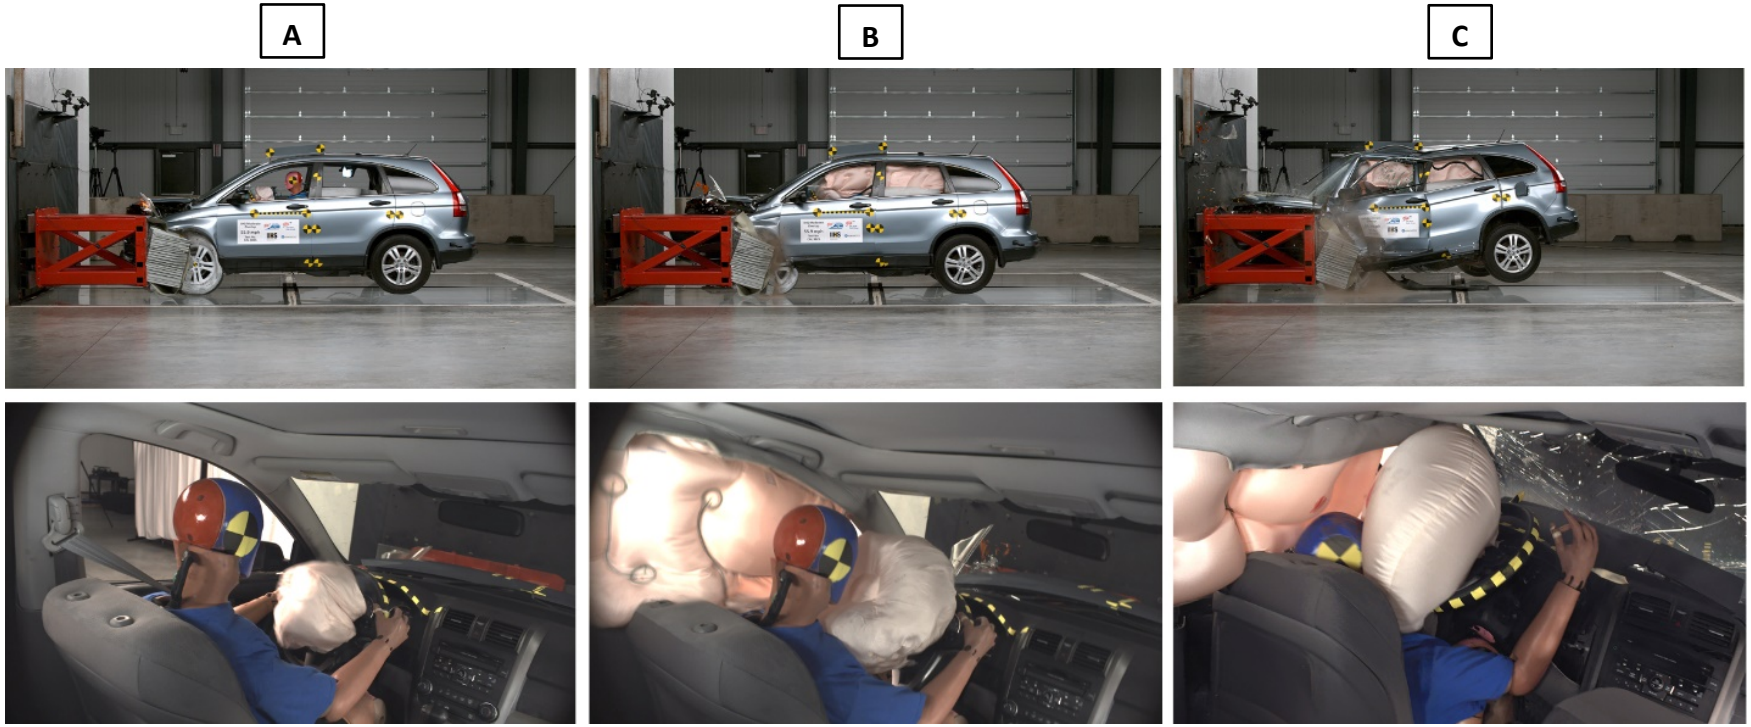
Figure 13. Vehicle and onboard views from Test 3 (90 km/h) at 50 ms (column A), 64 ms (column B) when peak vehicle longitudinal acceleration occurs, and 120 ms (column C)

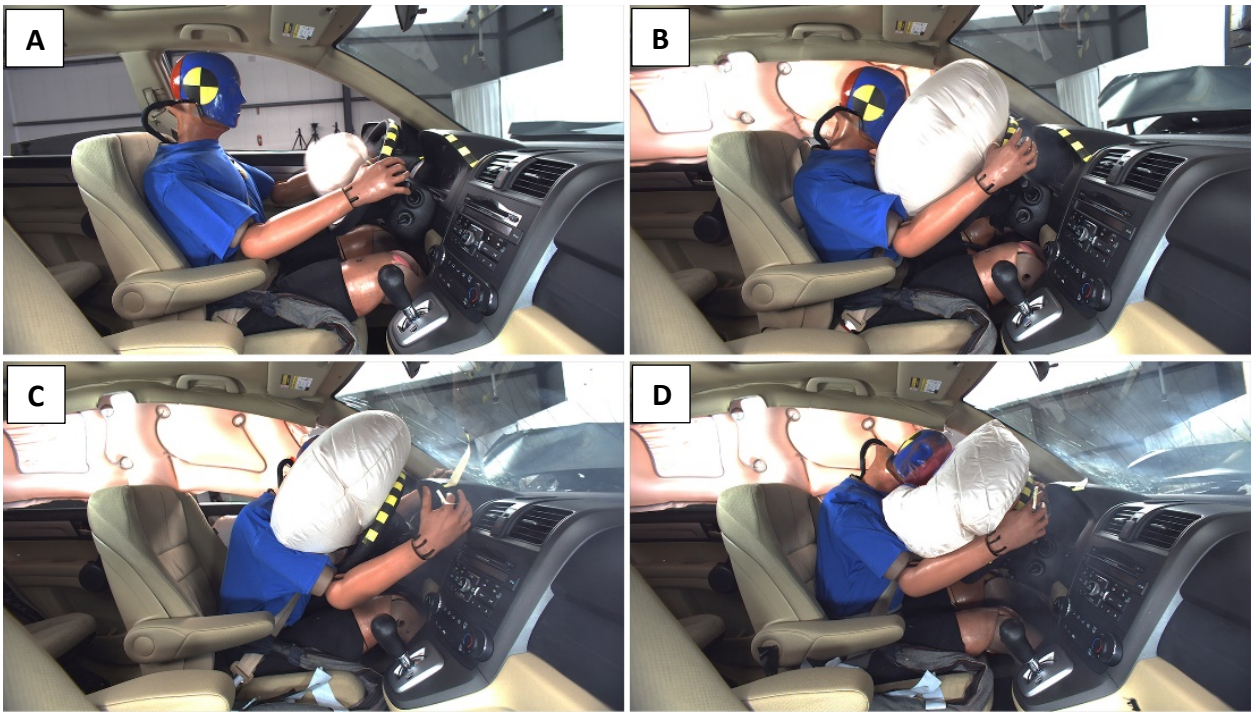
Figure 14. Test 1 dummy kinematics during forward loading (A at 54 ms and B at 88 ms) and rebound (C at 150 ms and D at 200 ms)

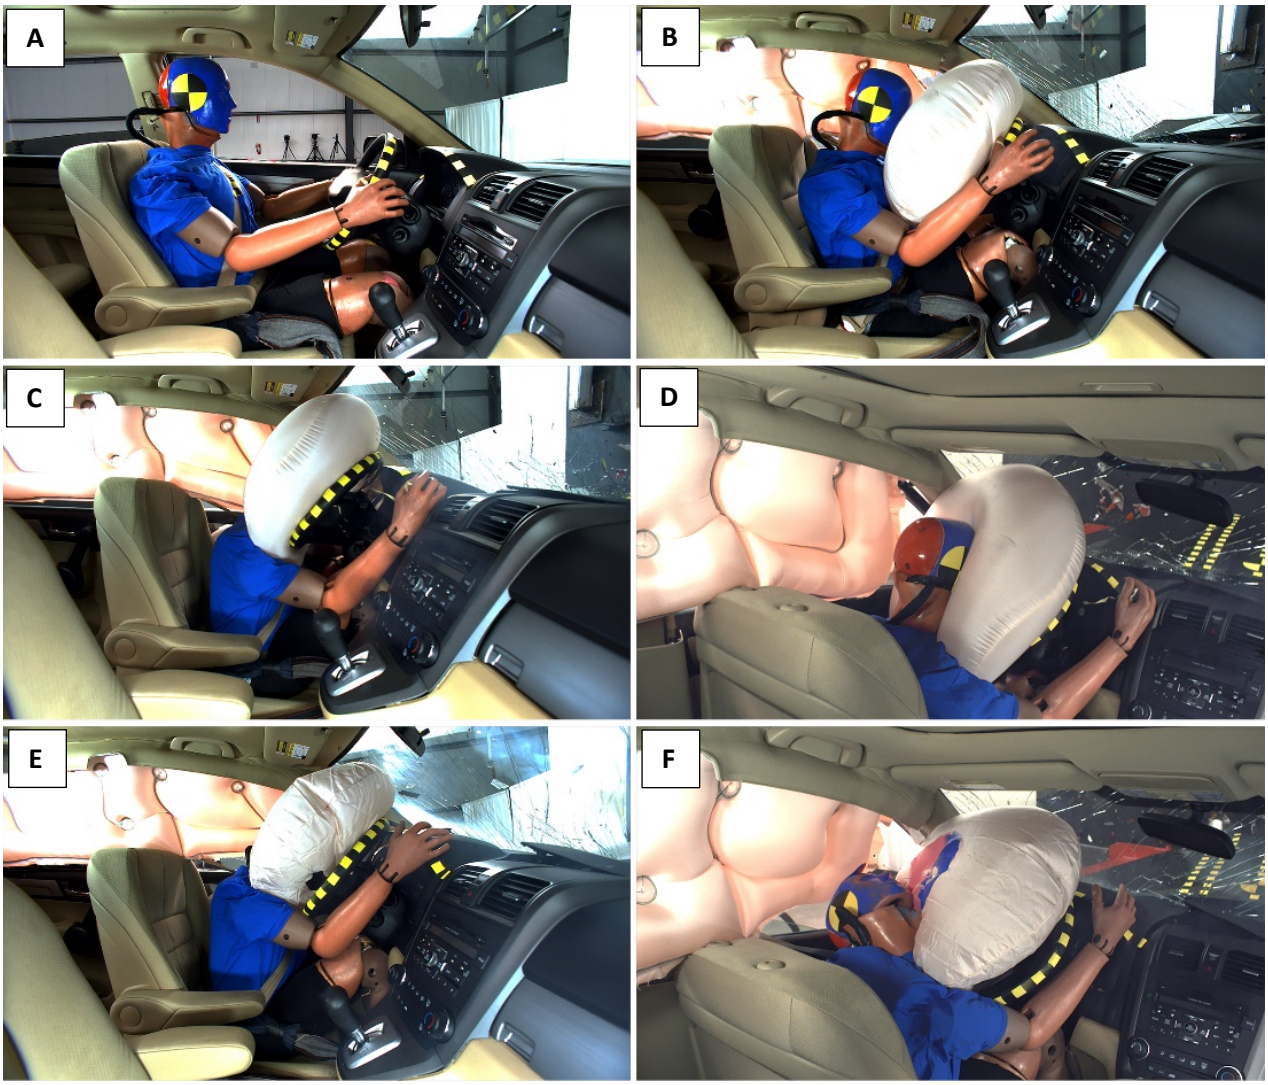
In Tests 2 and 3, the belt tensioner deployed at approximately the same time as in Test 1 (26 and 22 ms, respectively, see Table 4). However, the frontal airbag deployment time was approximately 10 ms earlier (Figure 15 – A for Test 2 and Figure 16 – A for Test 3) and the loading of the dummy face occurred 8 ms – 10 ms earlier (Figure 15 – B for Test 2 and Figure 16 – B for Test 3).

As the dummy continued to move forward into the airbag, the steering wheel rim rotated upward. The upward steering-wheel motion resulted in little airbag surface area loading the dummy's chest, with the airbag primarily loading the head/neck region (the airbag deployed at optimal position covers the head, neck, and chest). The higher energy in Tests 2 and 3 combined with the steering wheel upward movement resulted in the dummy's head bottoming out the airbag (i.e., going through the deployed airbag). This, consequently, resulted in a hard contact between the face and the steering wheel rim, hub or both at 99 ms in Test 2 (Figure 15 – C & D) and 90 ms in Test 3 (Figure 16 – C & D).

Figure 15. Test 2 dummy kinematics at airbag deployment (A at 46 ms), face loading the airbag (B at 80ms), bottoming of the steering wheel (C & D at 100 ms), and rebound (E & F at 150 ms)

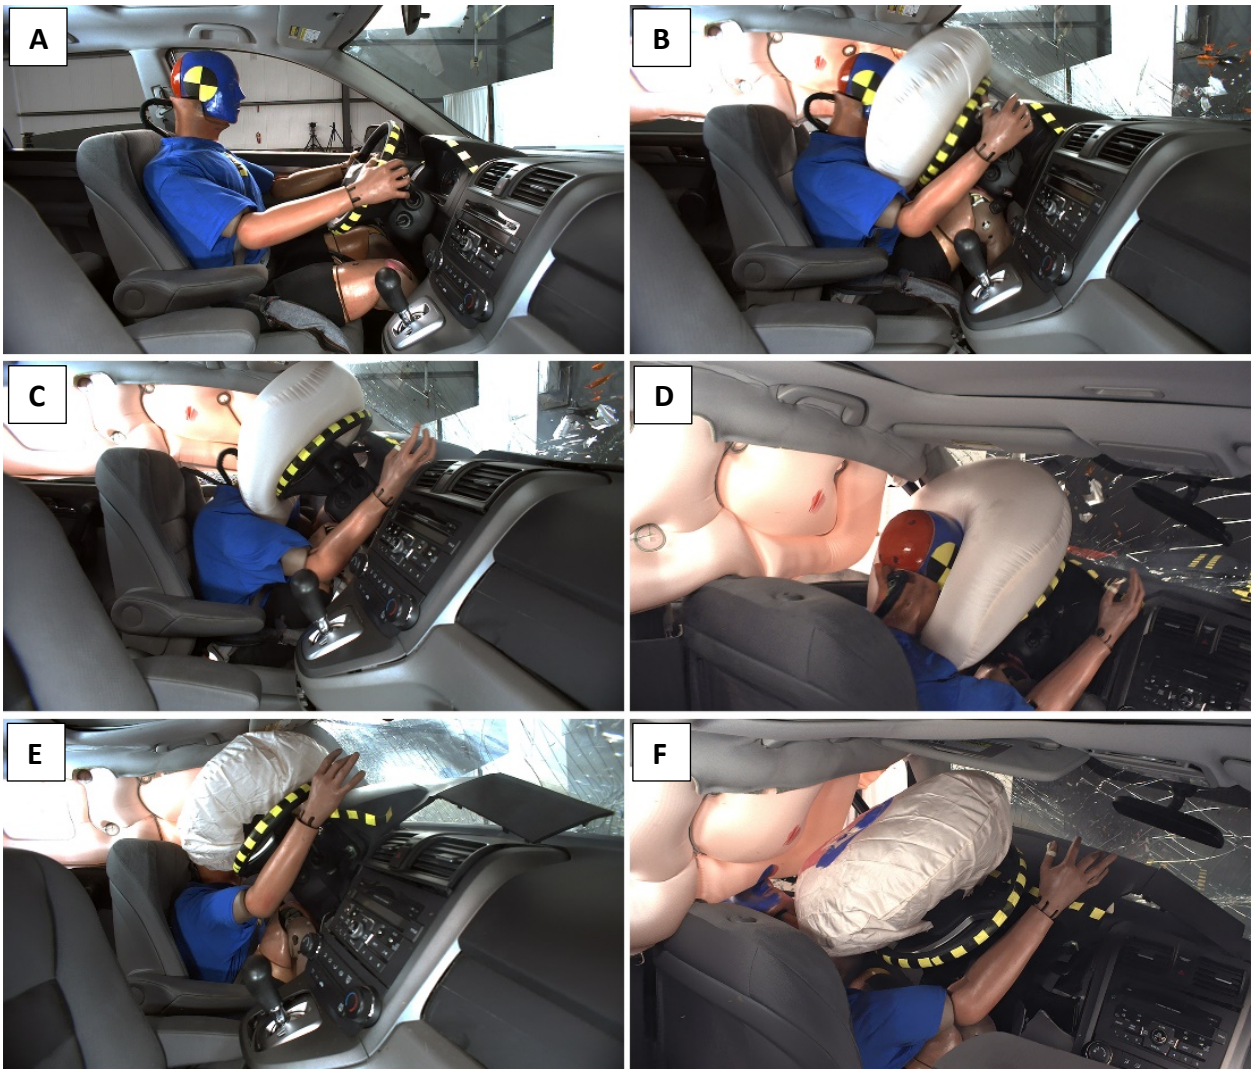
Figure 16. Test 3 dummy kinematics at airbag deployment (A at 44 ms), face loading the airbag (B at 78ms), bottoming of the steering wheel (C & D at 90 ms), and rebound (E & F at 150 ms)

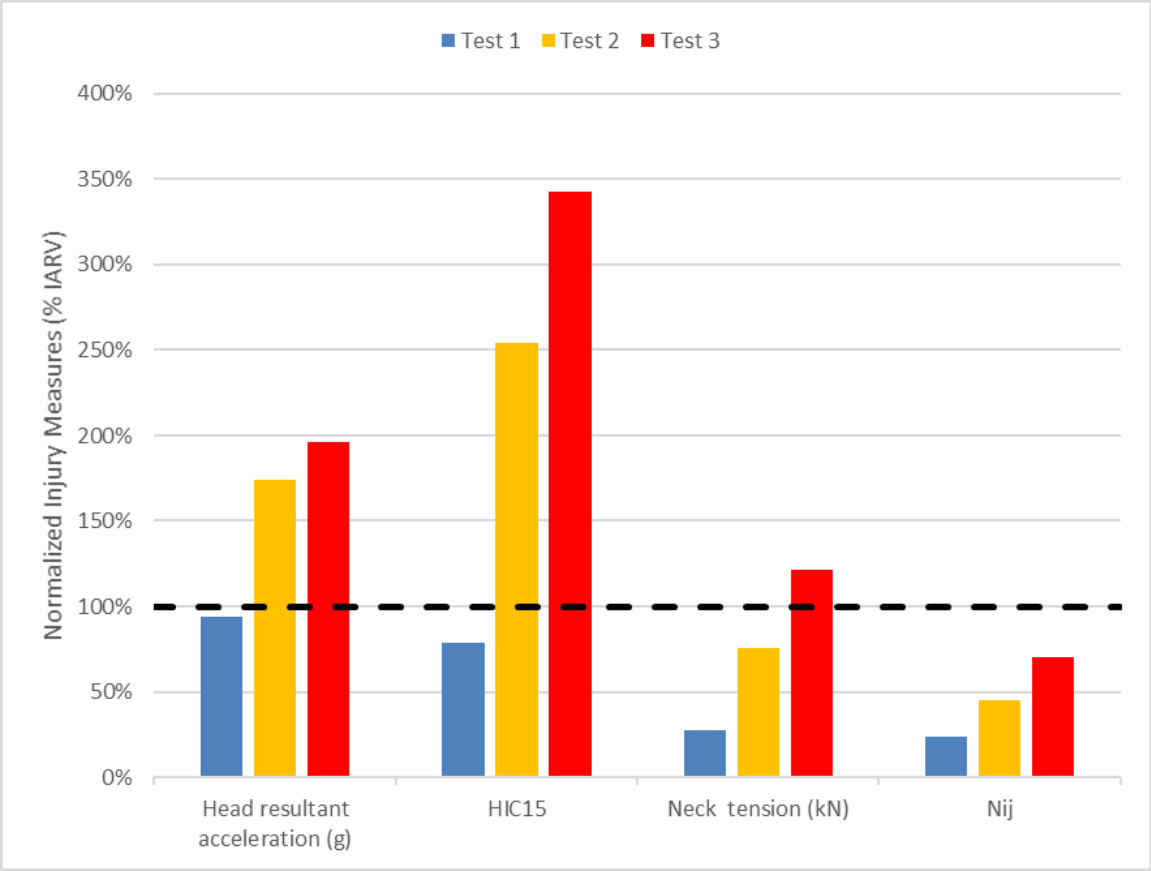
Figure 17. Head and neck injury measures normalized by IARV

In Tests 2 and 3, the contact through the airbag to the steering wheel rim/hub produced head accelerations and as a result Head Injury Criterion (HIC15) values greatly exceeded IARVs (i.e., greater than 100% in Figure 13). These high HIC15 values are indicative of a high risk (52% – 67%) of facial fracture and severe brain injury (Consumer Information; New Car Assessment Program, 2008). The peak neck tension seen in Test 3 (4.0 kN of neck axial tension in Appendix B3) corresponds to a 19% risk of a serious neck injury (Consumer Information; New Car Assessment Program, 2008).

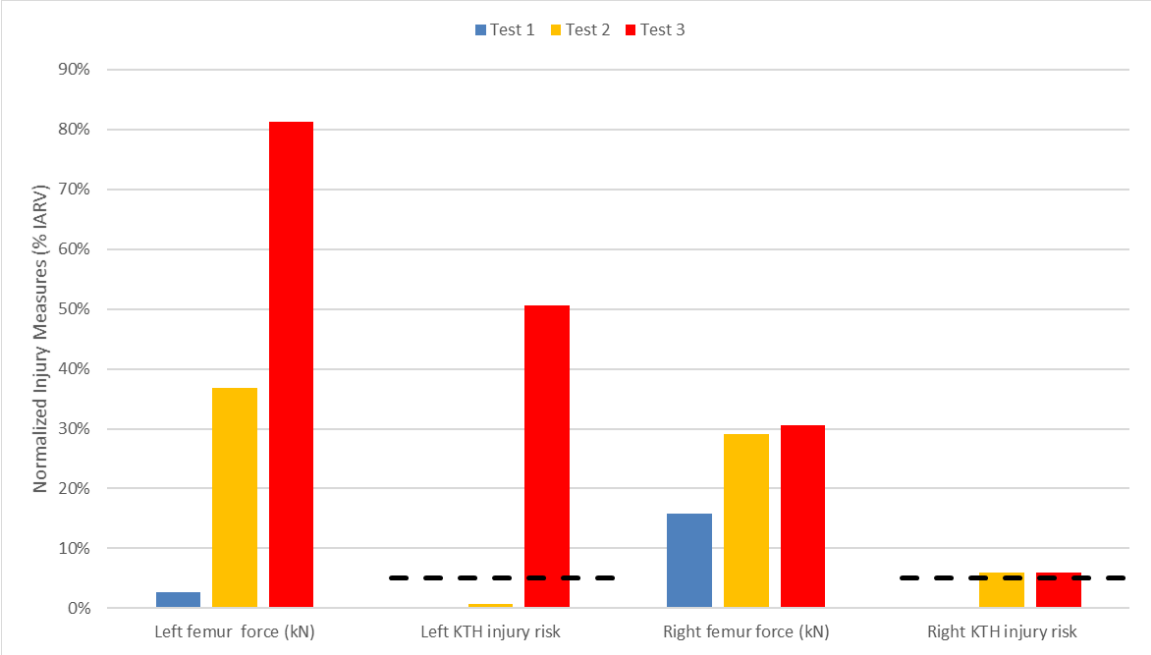
Figure 18. Femur injury measures

As with other body regions, loads to the lower extremities increased with test severity as well. Femur force increased in Tests 2 and 3 as shown in Figure 18. Especially in Test 3, very high peak left femur compressive force and impulse (load duration) indicates a 50% risk of a hip fracture (femoral neck fracture) (Rupp et al., 2009). The tests with higher impact speed also produced higher axial forces and bending moments to the lower legs, which resulted in Tibia

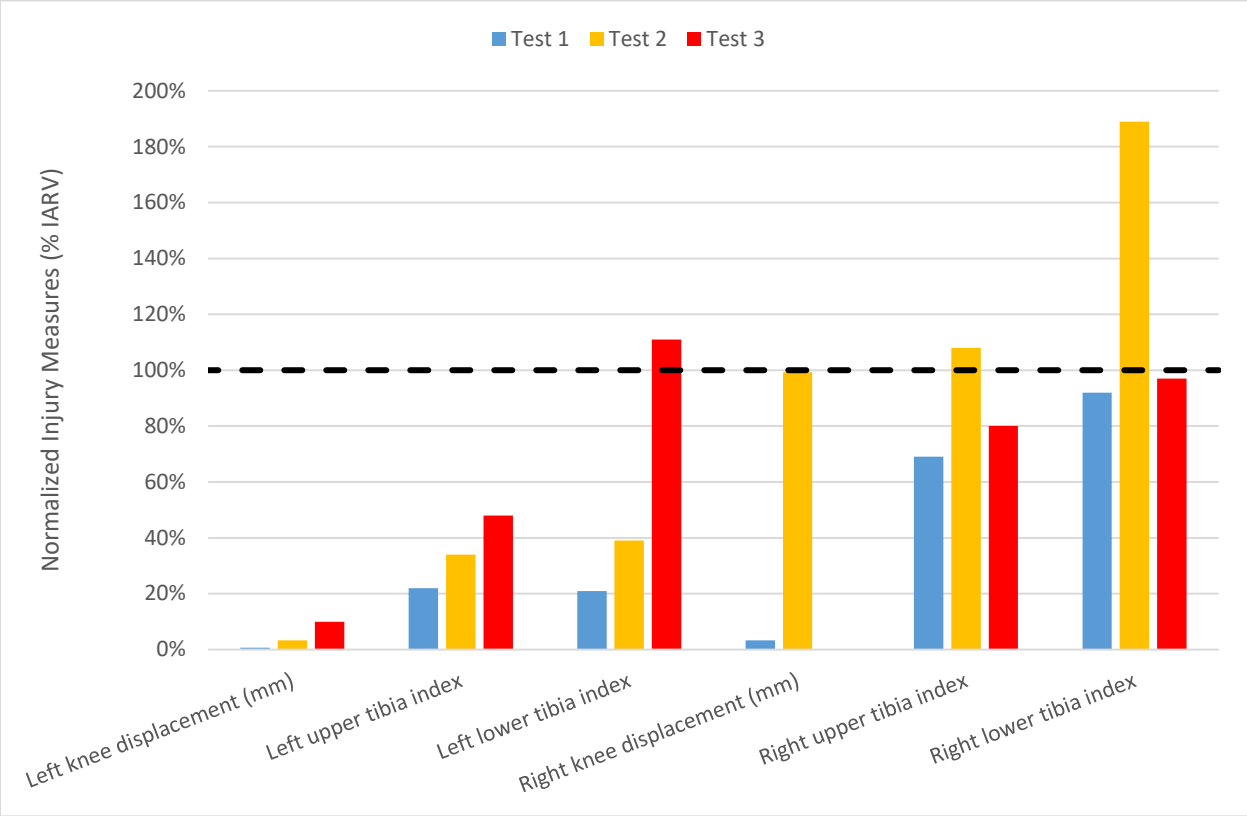
Figure 19. Lower leg injury measures normalized by IARV

Index values that correspond to a higher likelihood of fracture to the long bones in the lower leg (tibia, fibula, or both).

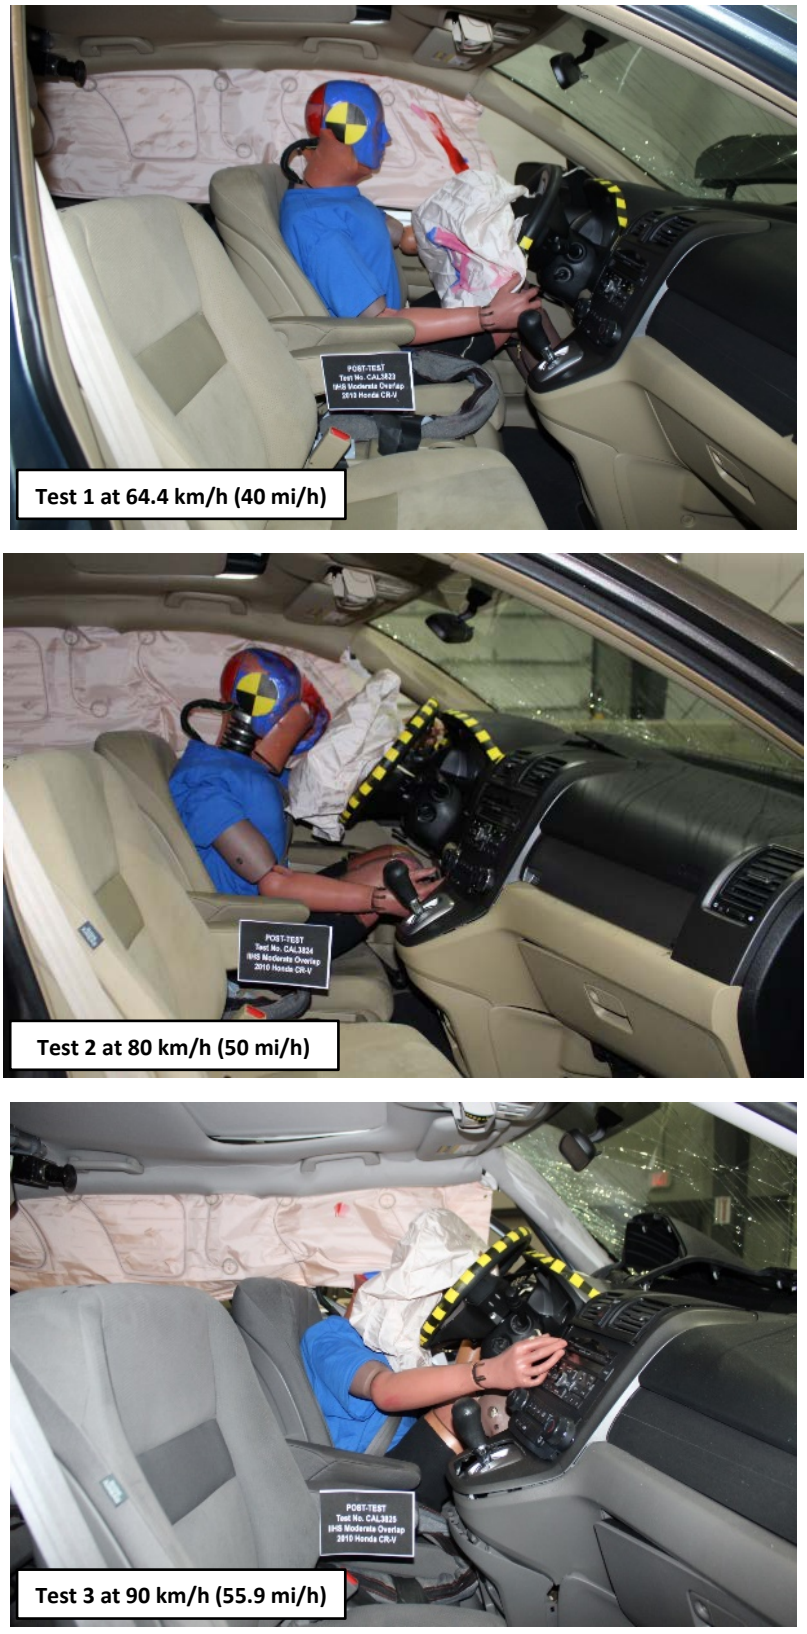
Figure 21. Visual comparison of occupant compartment between the three tests

If each test vehicle were rated per IIHS protocols (IIHS, 2006, 2007, 2014, and 2017), only the baseline test would earn a rating of Good, with Good ratings for the injury, structure, and restraint and kinematics components that make up the overall rating (Table 5). Tests 2 and 3 would earn a poor overall score, with Test 2 results heavily influenced by the elevated head injury measures, and Test 3 by elevated injury measures to vital body regions and the heavily compromised occupant compartment.

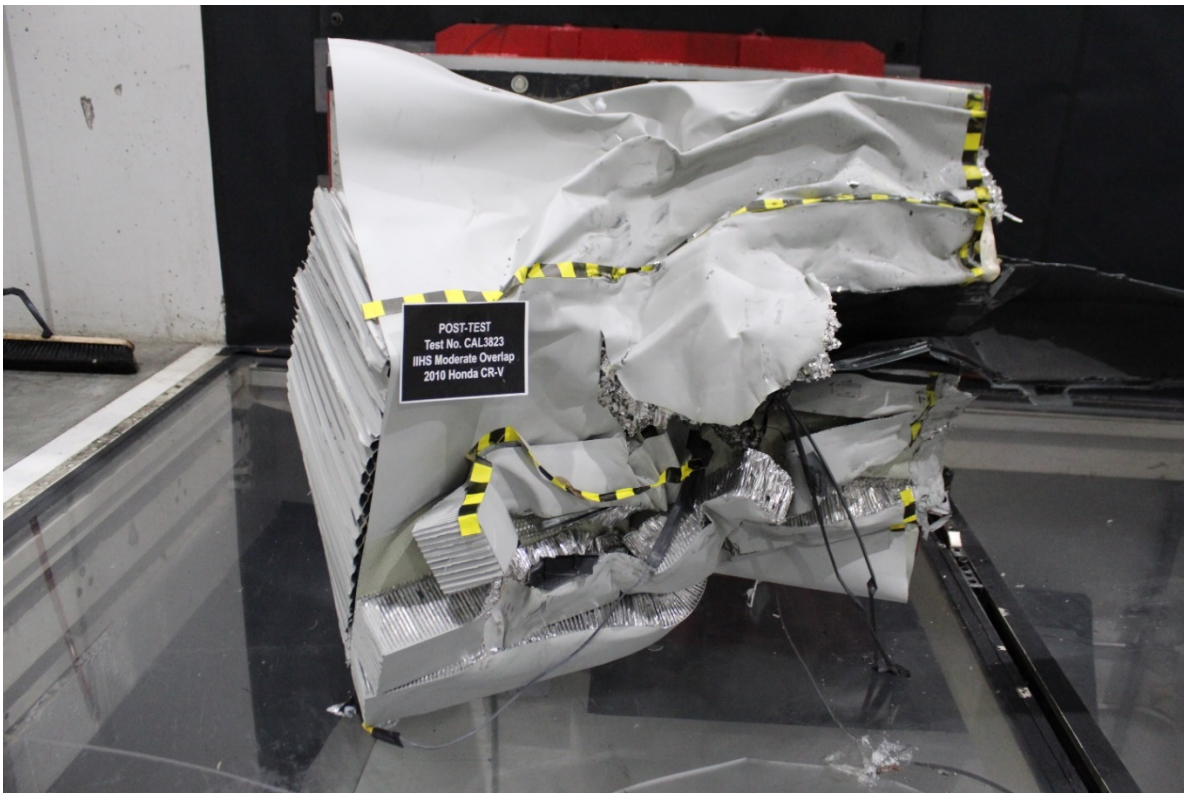
Front view of deformed barrier

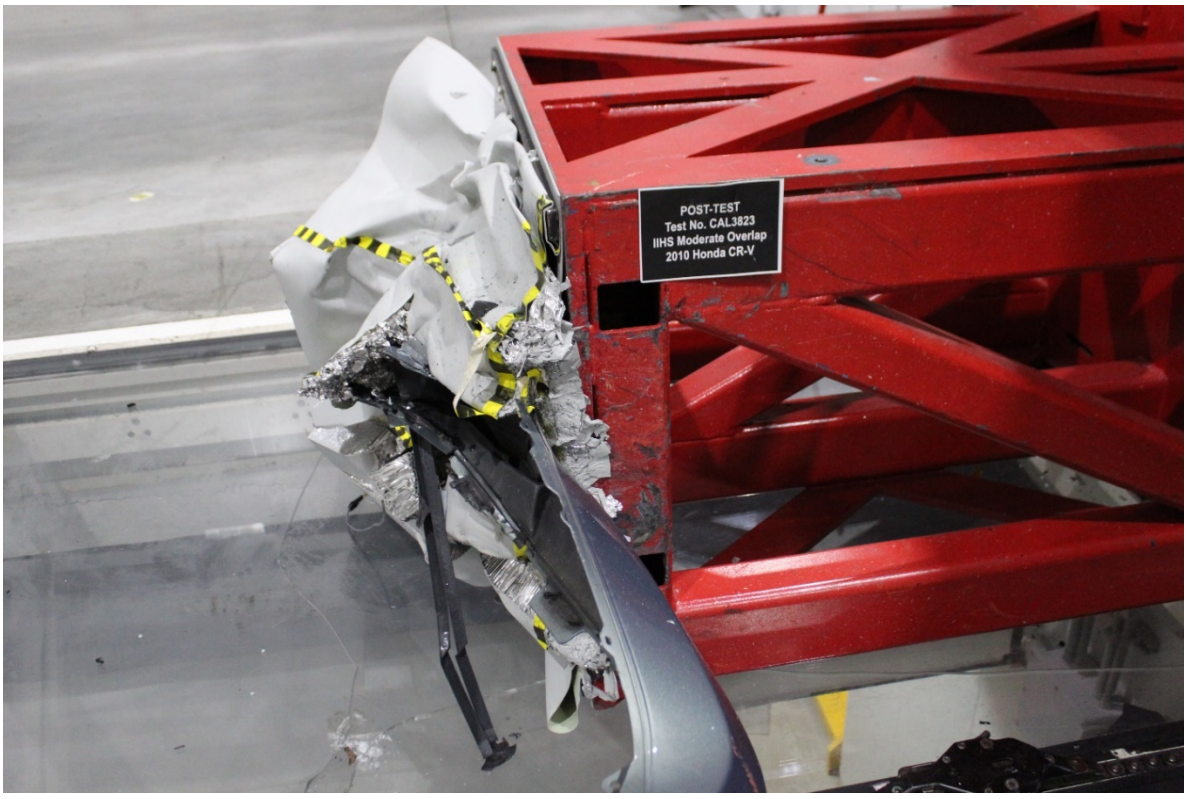
Right side view of deformed barrier

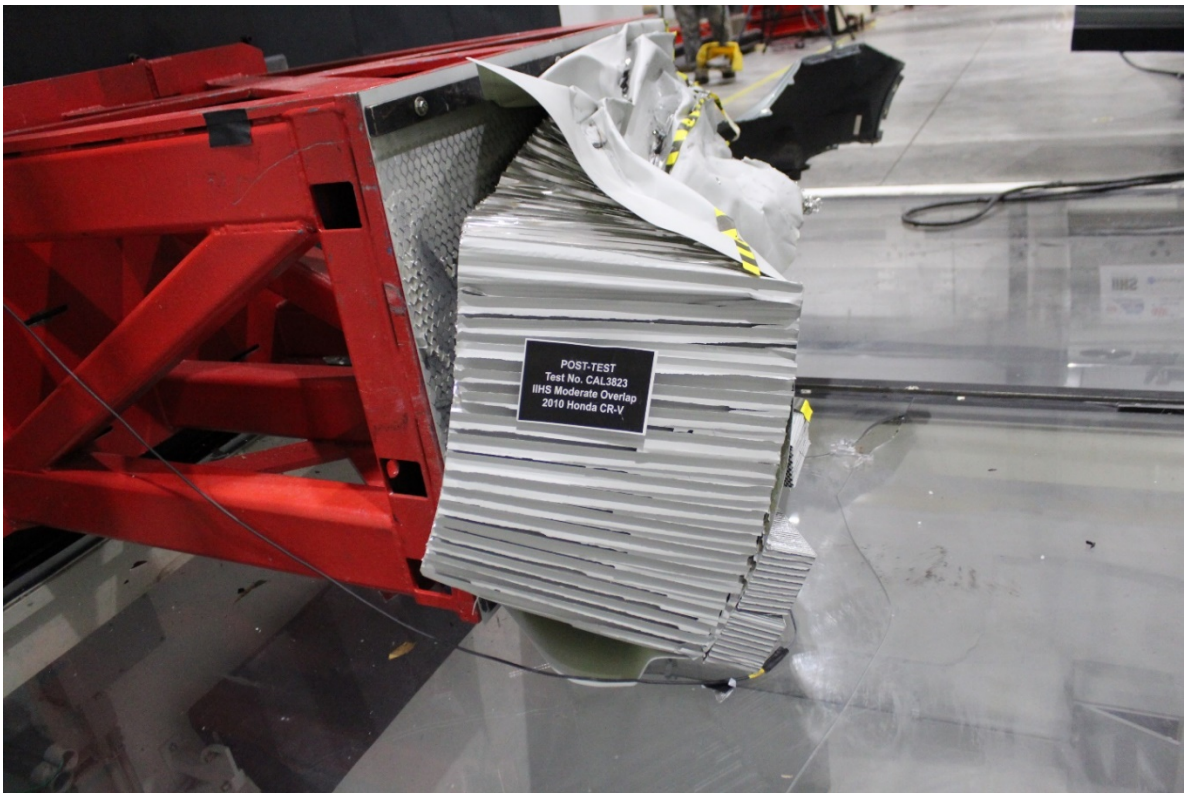
Left side view of deformed barrier

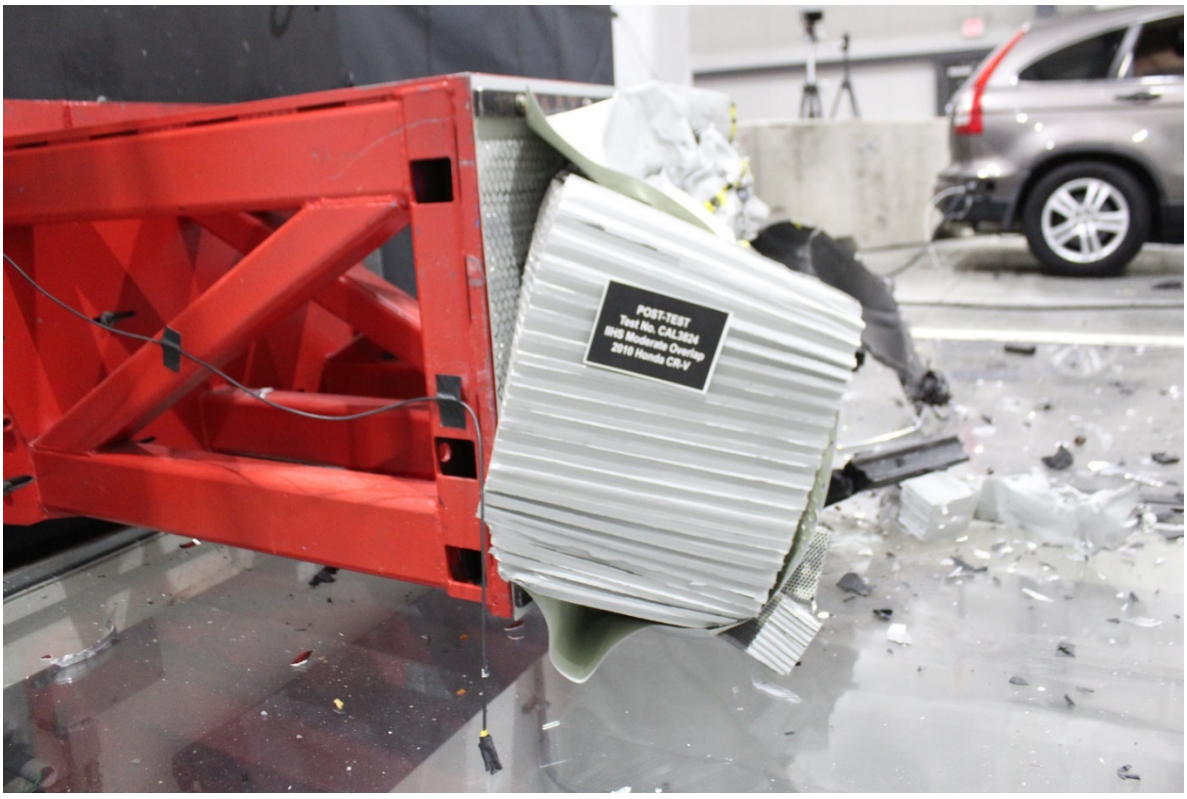
Left side view of deformed barrier

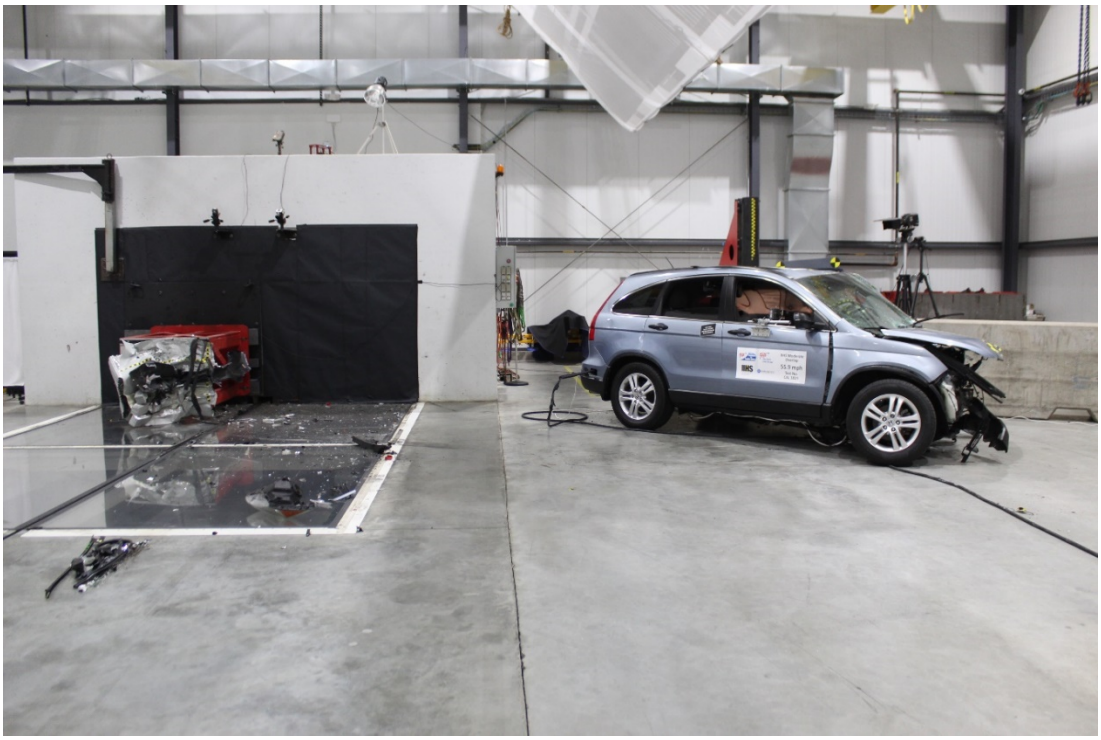
Overview after Test 3

Test vehicle after Test 3

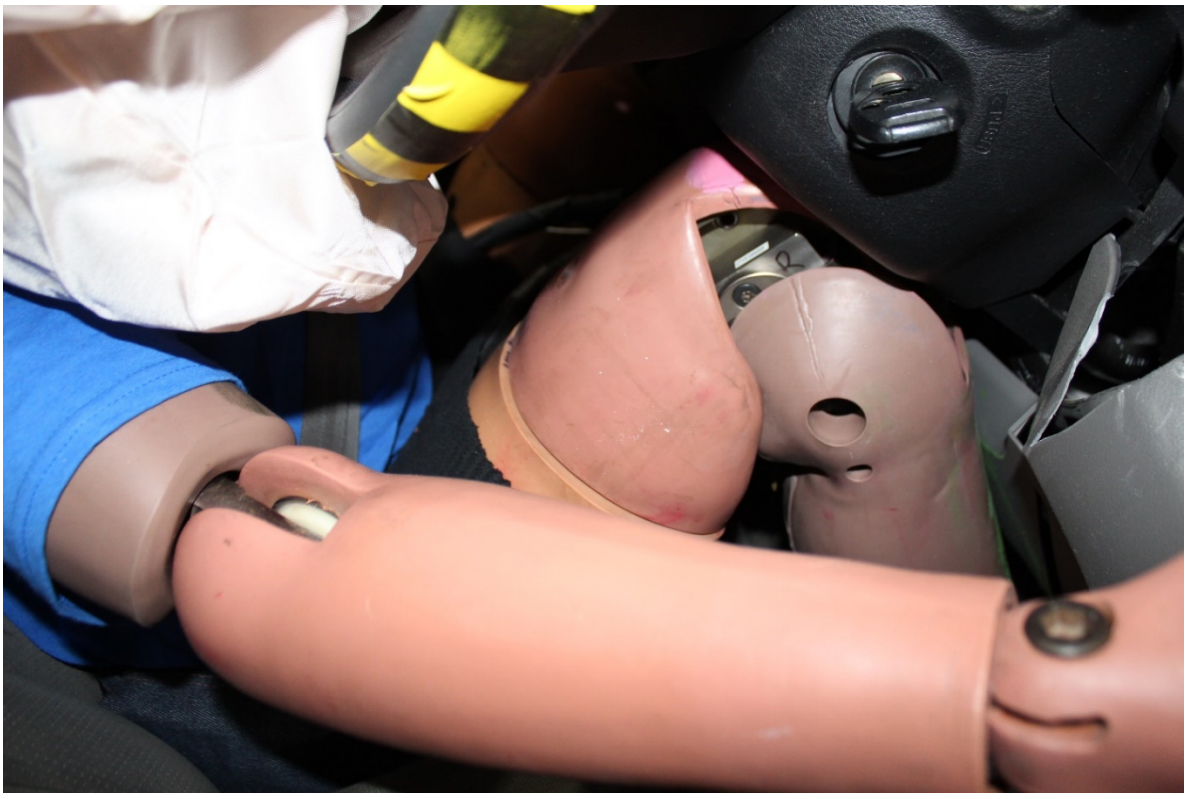
Dummy’s right knee contacting the steering wheel column

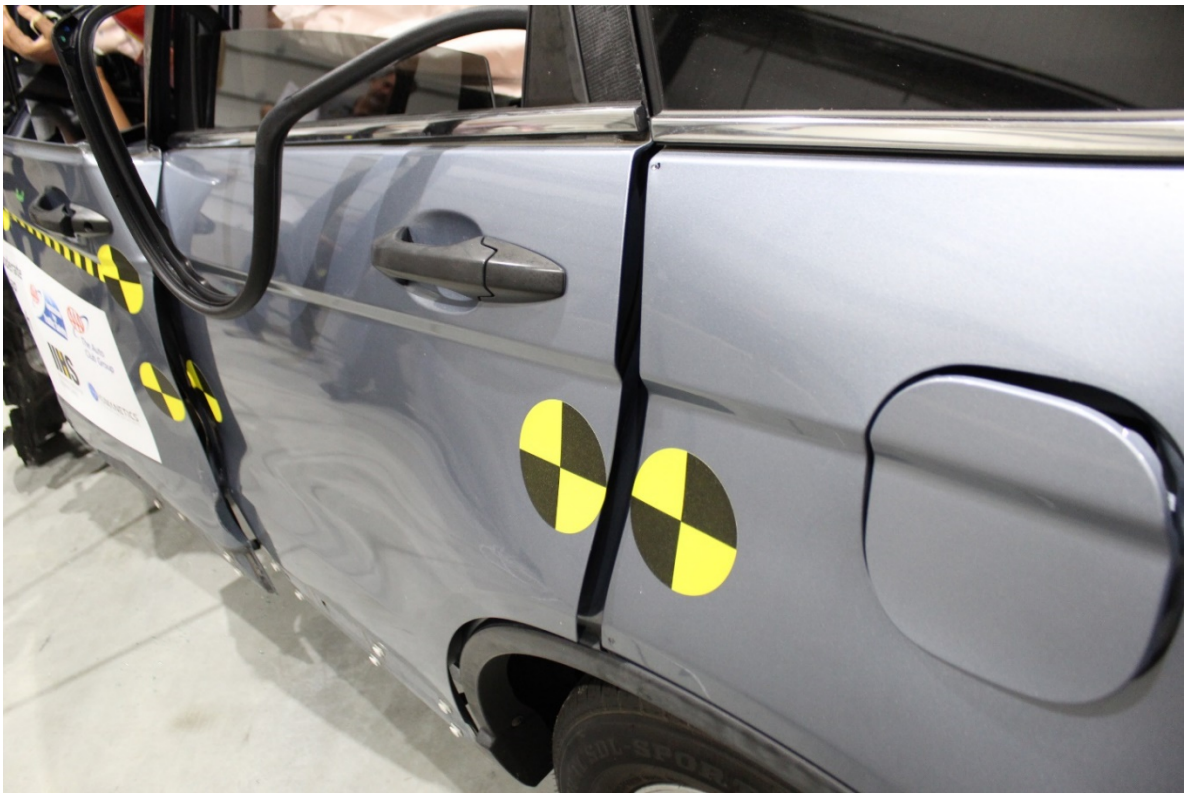
Driver side’s rear door and fuel door

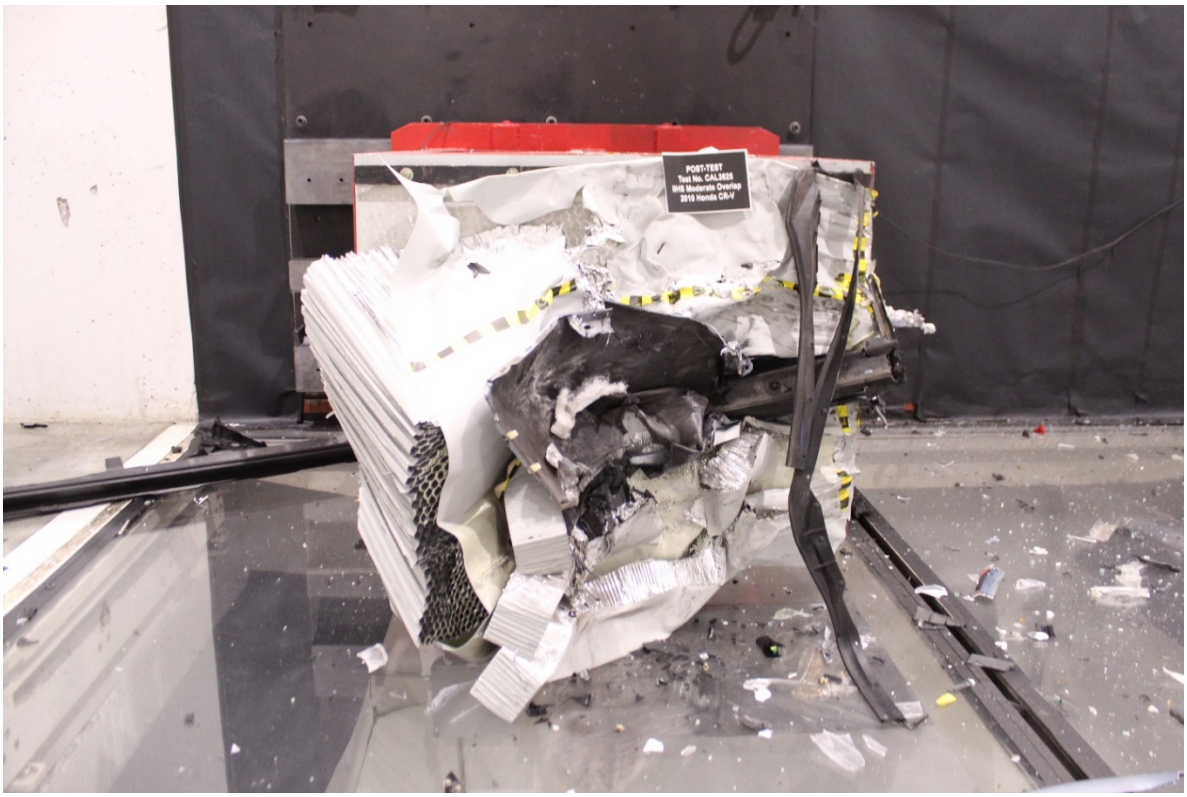
Front view of deformed barrier
