OCTOBER 2023

# THE ACCURACY OF TIRE PRESSURE MONITORING SYSTEMS

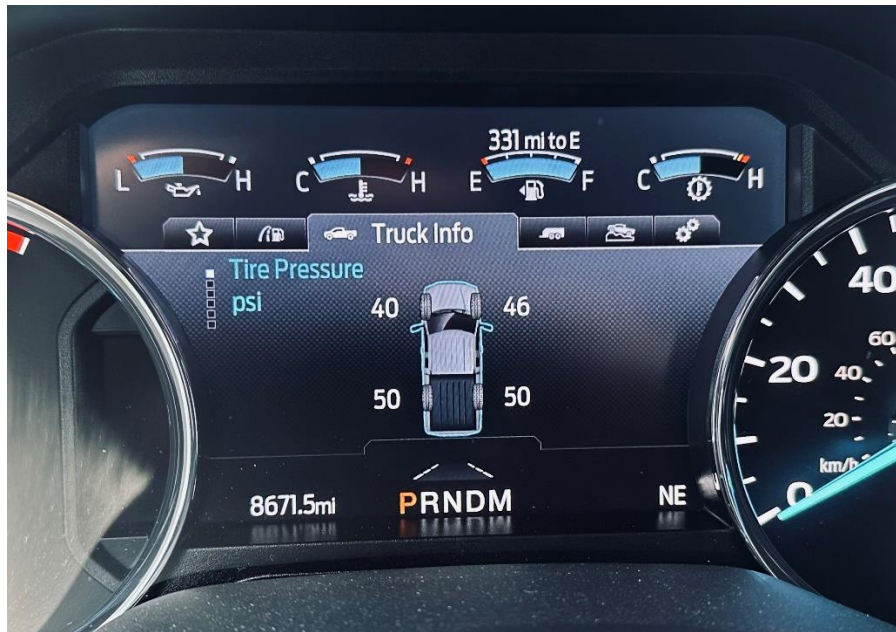
The 2022 Ford F-250 did not illuminate the TPMS light or provide any warning message after the left front tire was deflated to 65 percent of placard pressure and driven a short distance of no more than one mile. It is important to note that the tire pressure at each corner updated immediately after adjustment with no driving required.

Figure 7: 2022 Ford F-250 with left front tire inflated to 65 percent of placard pressure. Image Source: AAA.

The 2022 Ford F-250 was the only test vehicle that did not illuminate the TPMS light even when one tire was only inflated to 65 percent of placard pressure. However, this vehicle has a GVWR of 10,000 lbs. which is at the upper limit of vehicles mandated to have TPMS.

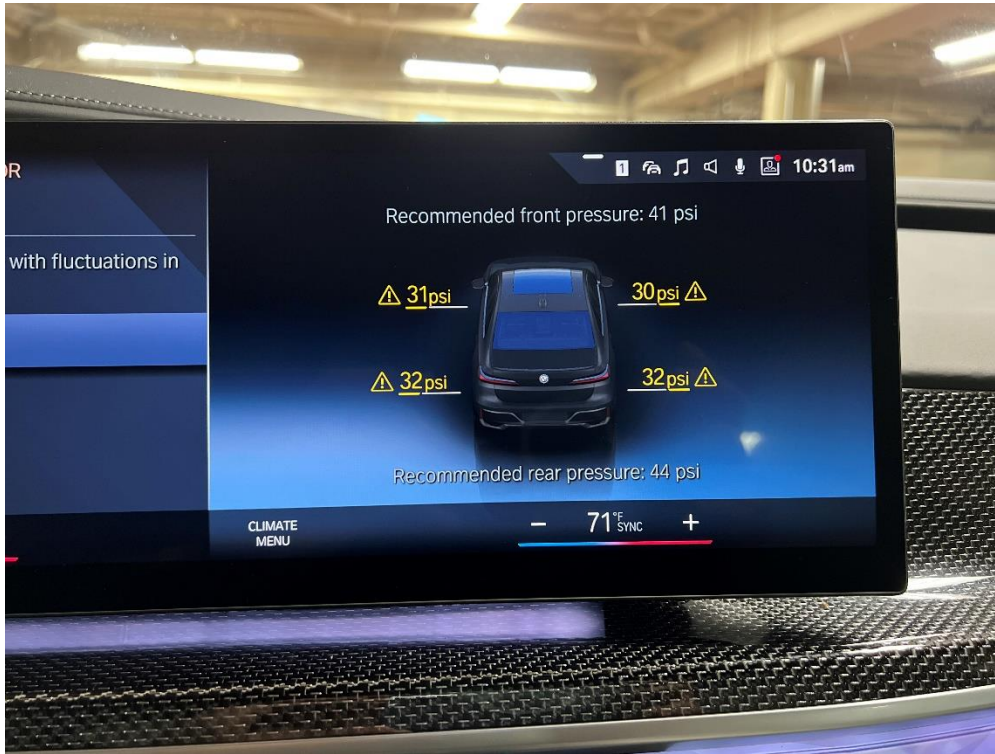
Figure 8: 2023 BMW i760x display at 75 percent of placard pressure. Image Source: AAA.

It is important to note that all test vehicles displayed tire pressures with similar margins of error relative to measurements taken at placard pressure as described within [Inquiry 1](#). Pictures of displayed tire pressures at 75 percent of placard pressure are provided in the Appendix.

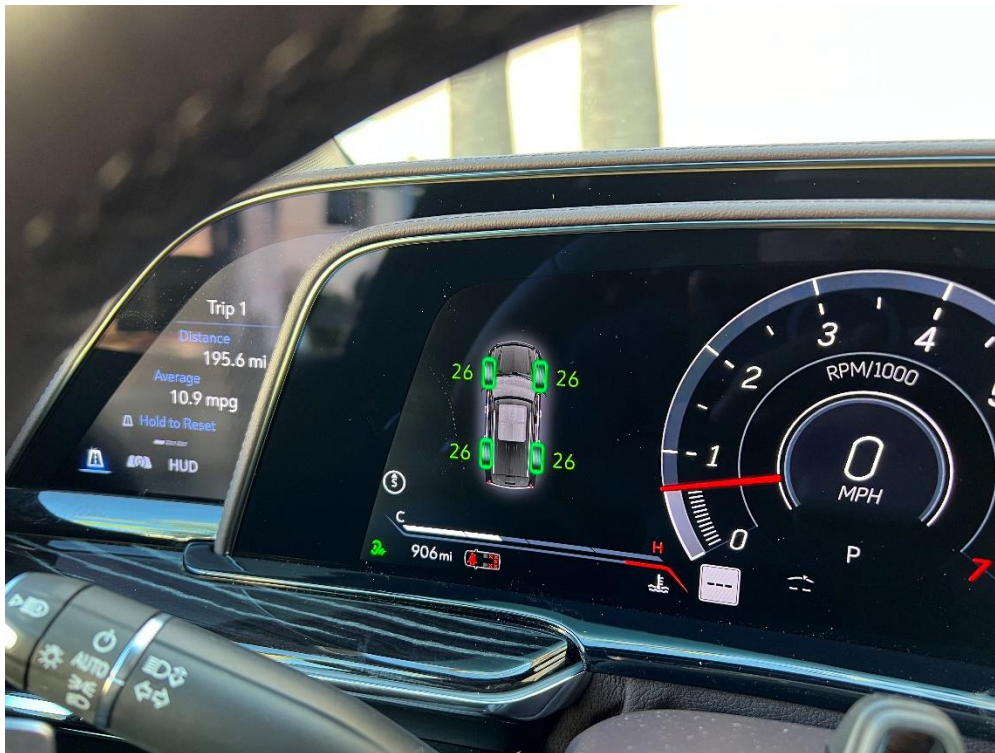
Figure 9: 2023 Cadillac Escalade display at 75 percent of placard pressure. Image Source: AAA.

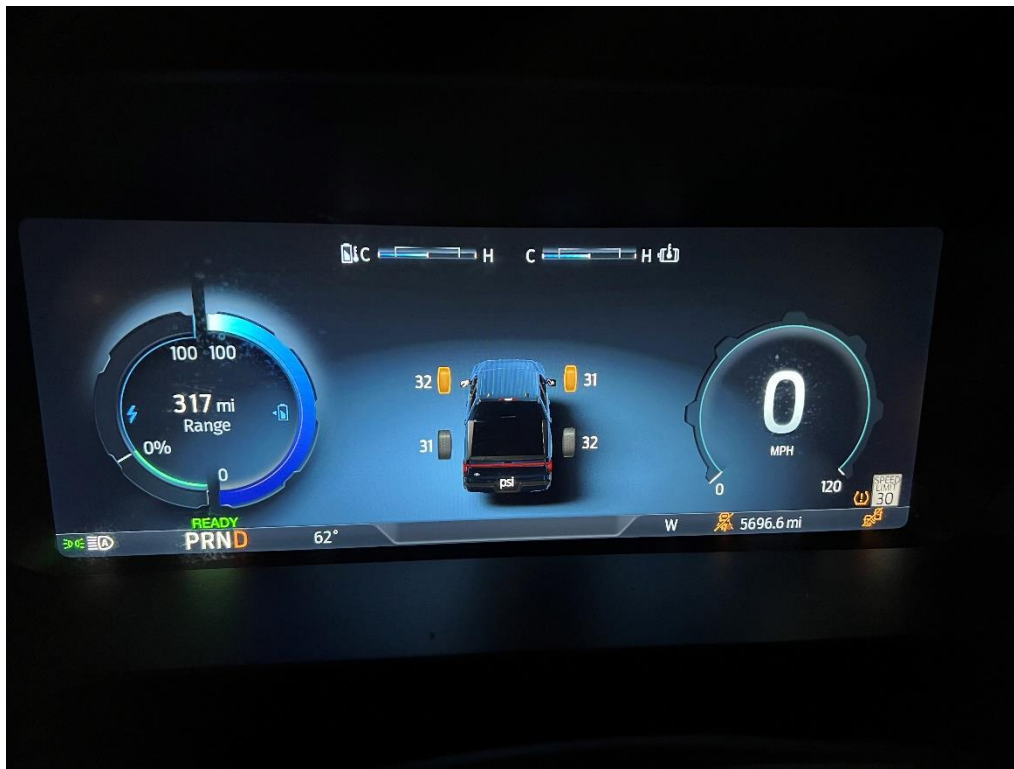
Figure 10: 2022 Ford F-150 Lightning display at 75 percent of placard pressure. Image Source: AAA.

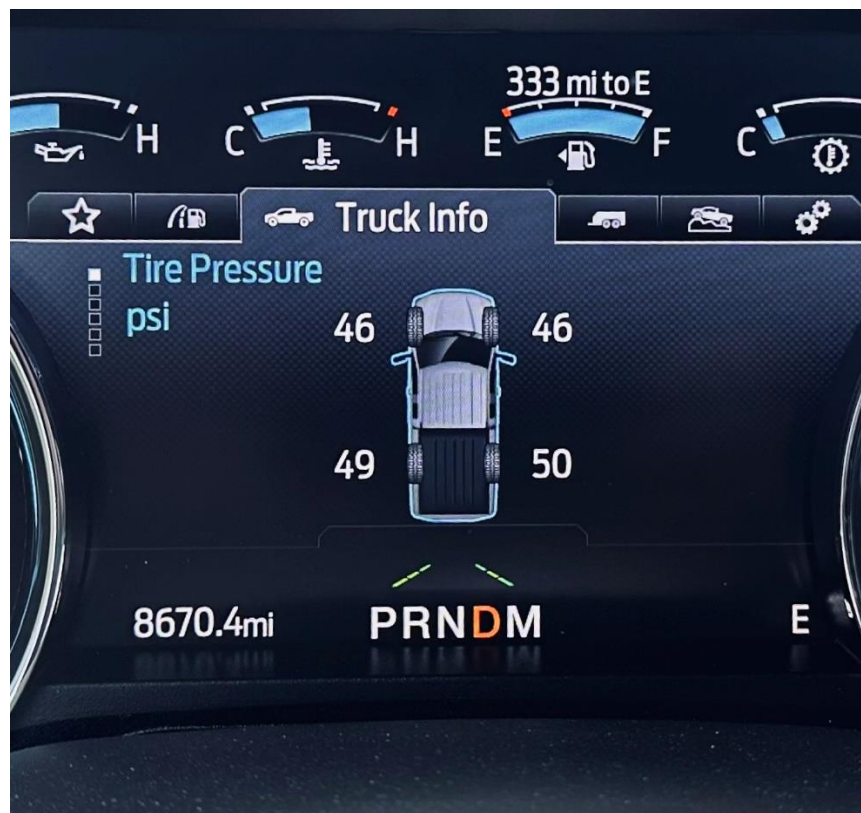
Figure 11: 2022 Ford F-250 display at 75 percent of placard pressure. Image Source: AAA.

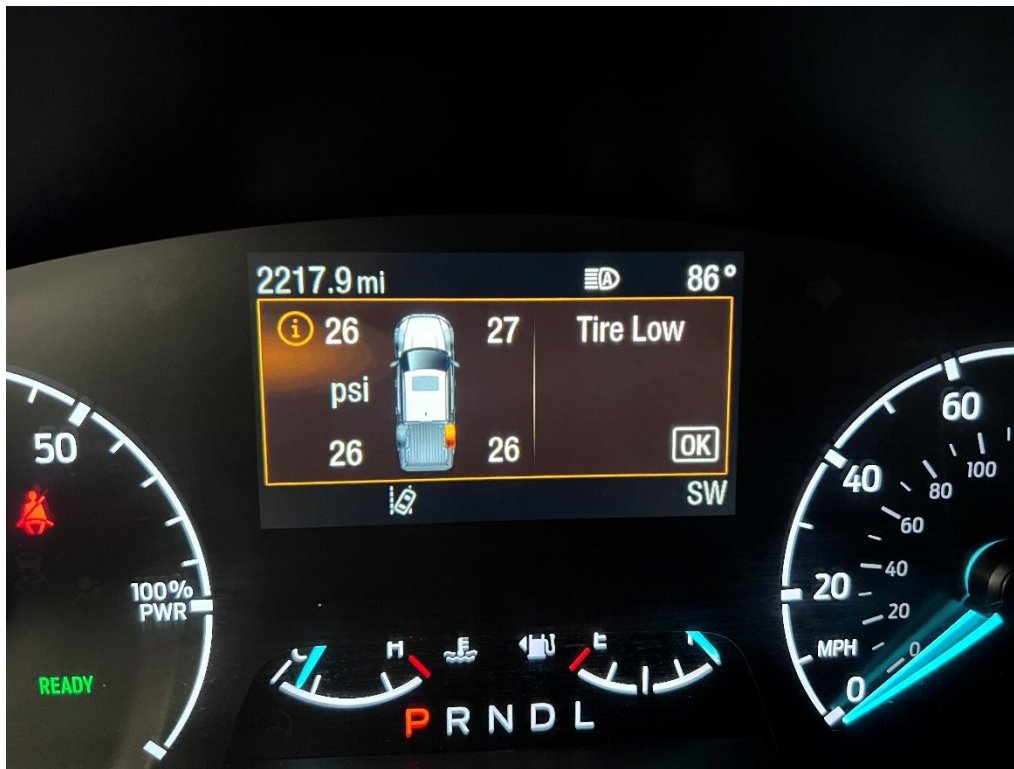
Figure 12: 2023 Ford Maverick display at 75 percent of placard pressure. Image Source: AAA.

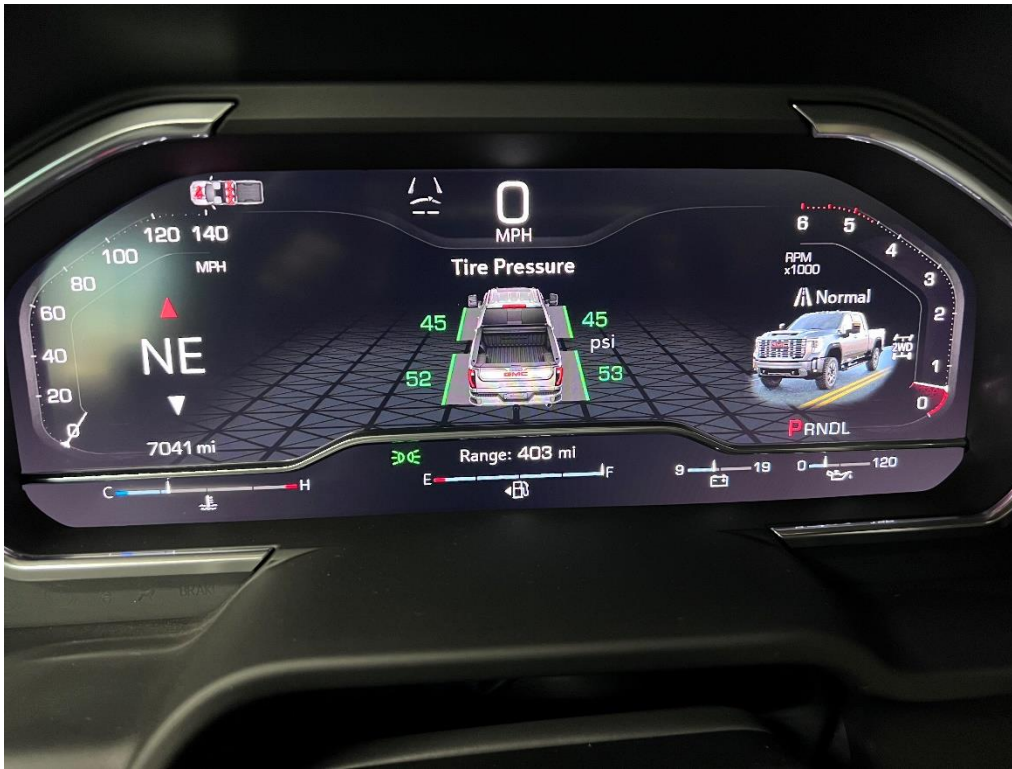
Figure 14: 2024 GMC Sierra 2500 display at 75 percent of placard pressure. Image Source: AAA.

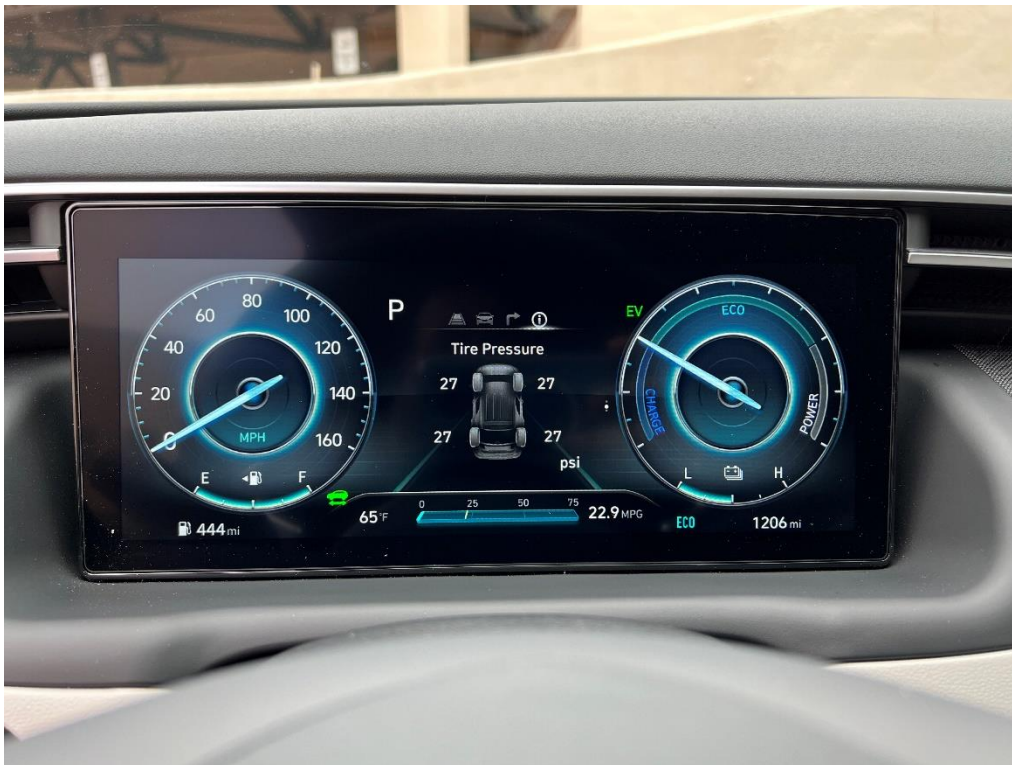
Figure 15: 2023 Hyundai Tucson display at 75 percent of placard pressure. Image Source: AAA.

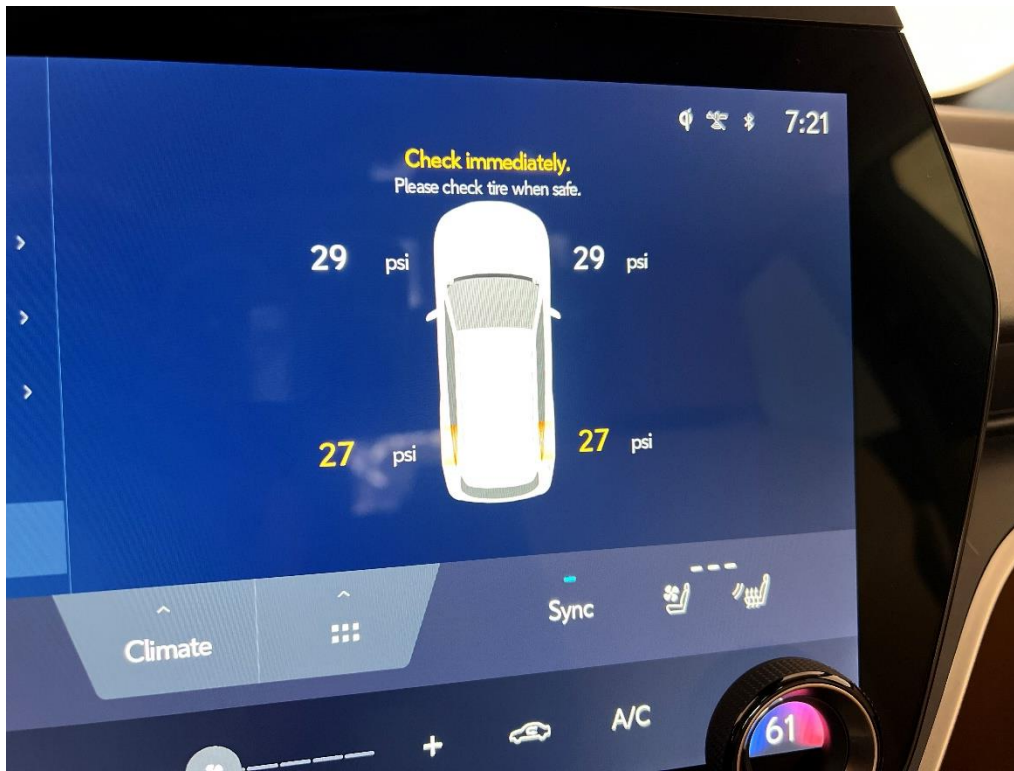
Figure 16: 2023 Lexus RZ450e display at 75 percent of placard pressure. Image Source: AAA.

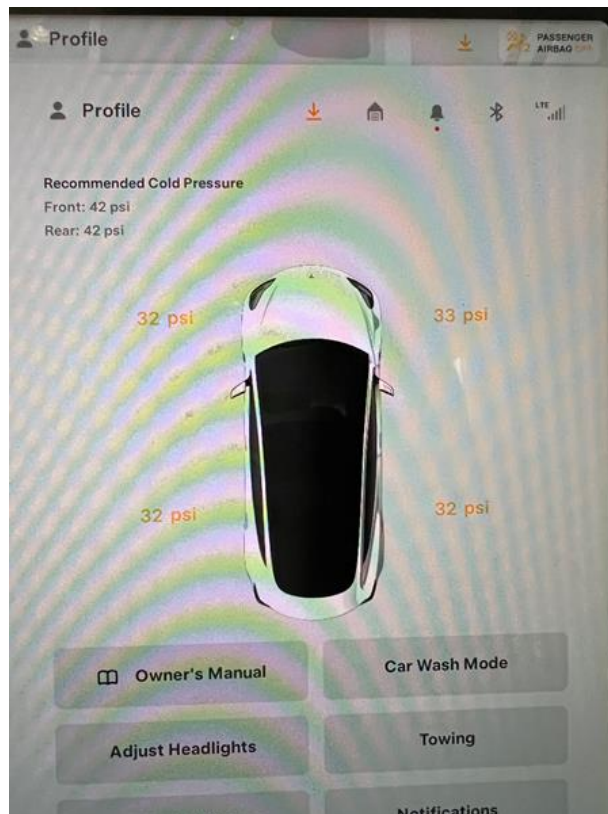
Figure 17: 2023 Tesla Model 3 display at 75 percent of placard pressure. Image Source: AAA.

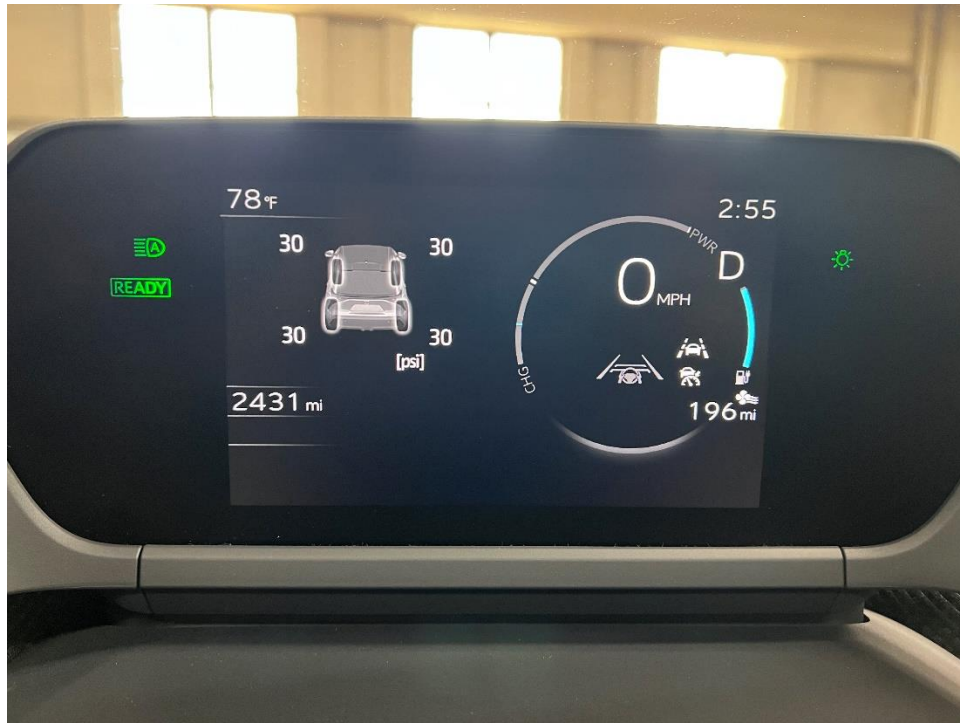
Figure 18: 2023 Toyota bZ4X display at 75 percent of placard pressure. Image Source: AAA.
